RESERVE FUND STUDY

FRONTIER BUSINESS PARK
CONDOMINIUM CORPORATION #1010603
240040 FRONTIER PLACE S.E.
ROCKY VIEW, ALBERTA

MAY, 2012

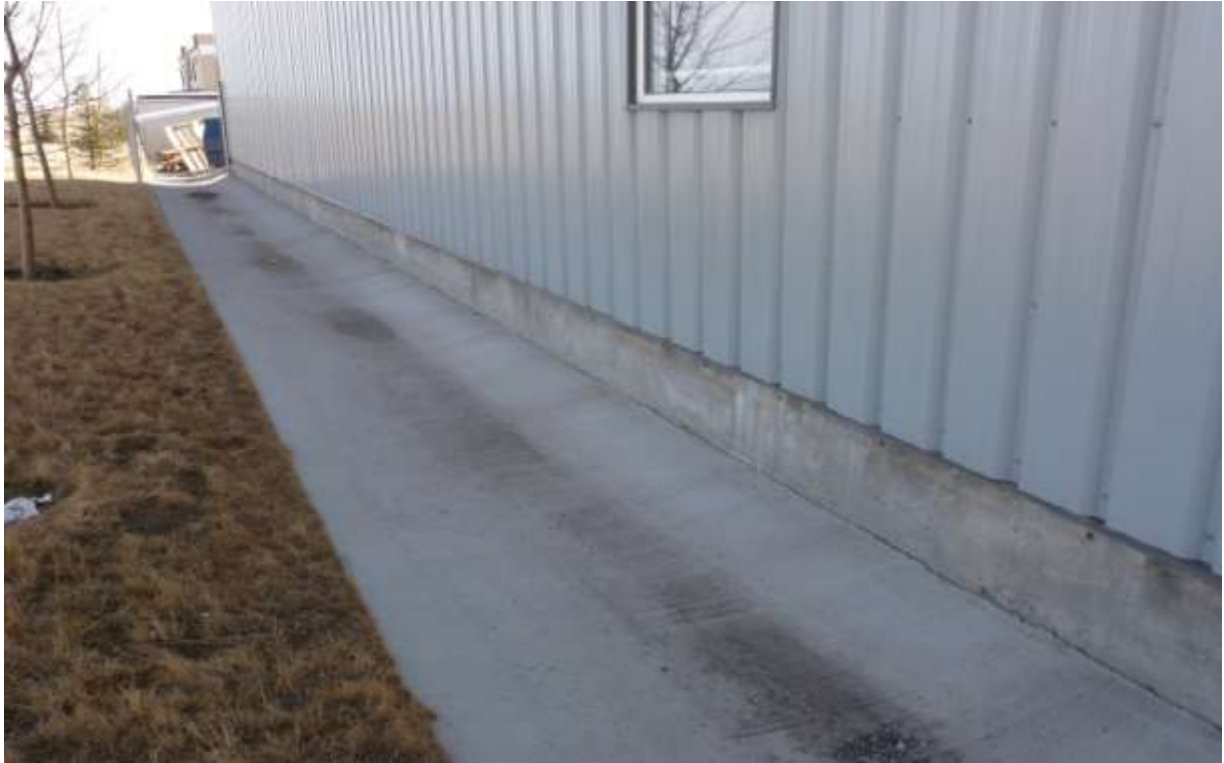
Figure 1-1

Estimated Year of Major Repair or Replacement	2035
Deficiency Analysis	No deficiencies were identified.

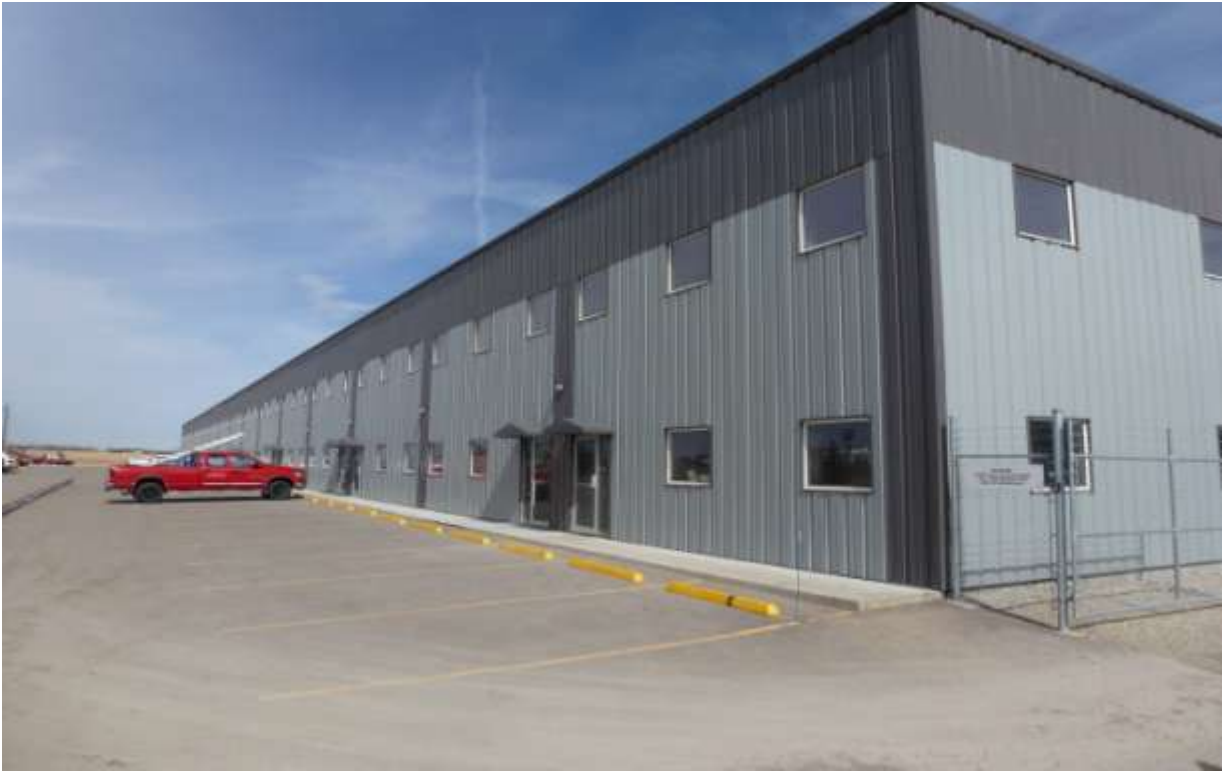
Figure 2-1

Condition Analysis	The metal walls and roof appeared in good condition. The utility room door was also in good condition.	
Life Cycle Analysis	Date of Acquisition:	2010
	Normal Life Span	25 years
	Effective Age	3 years
	Remaining Life Span	22 years
Unit Quantity And Cost Estimates	Unit Quantity	Allowance.
	Unit Cost Estimate	\$10,000
	Current Repair or Replacement Cost Estimate	\$10,000
	Estimated Year of Major Repair or Replacement	2035
Deficiency Analysis	No deficiencies were noted. Funds have been included every 6 years starting in 2019 to conduct a roof inspection and do any minor repairs like re-caulking around openings.

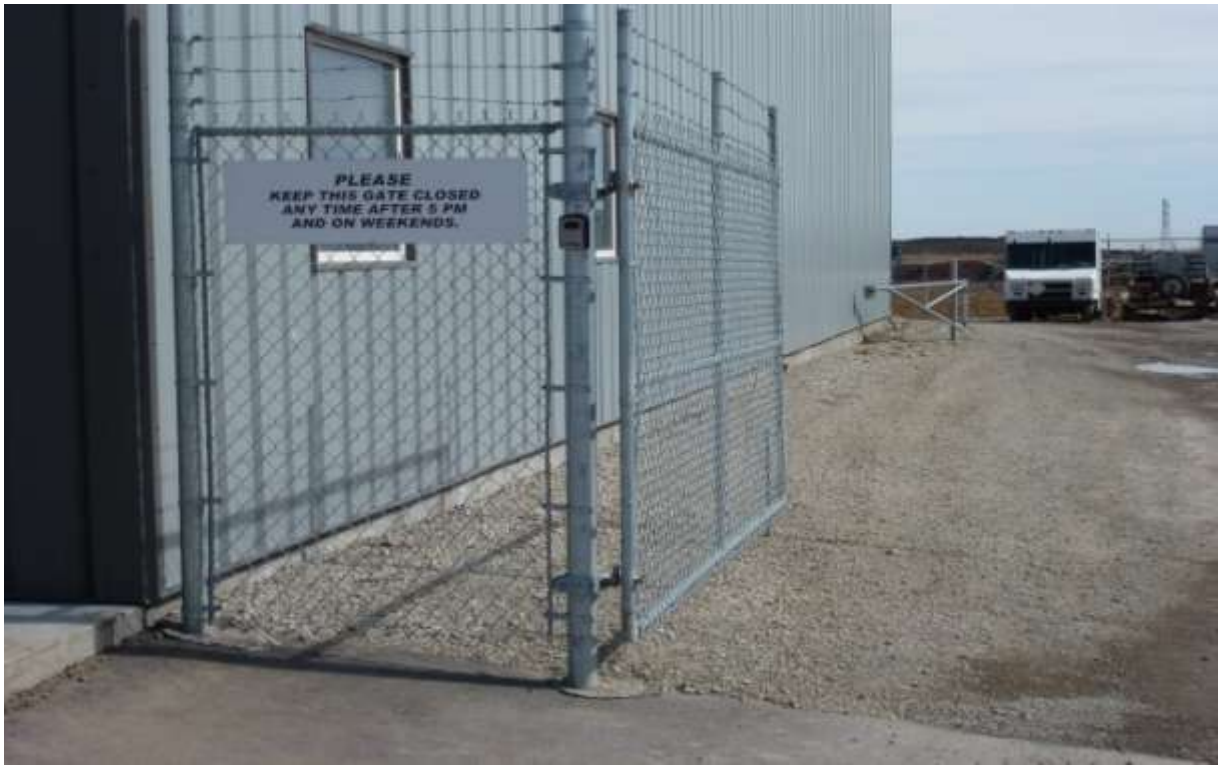
Figure 9-1

Reserve Component: (9) Site Improvements – Fence &Gates									
Physical Description	This component includes the chain link fence around the back of the complex as well as two 25 foot entrance gates and two secondary swing gates. It is being assumed that 50% of the fence and gates will be replaced over a 25 year period. See Figure 9-1& 9-2.								
Financial Analysis	There has been an expenditure of \$1650 on installing secondary swing gates in 2011/2012.								
Potential Deterioration	Chain link fence can come loose from the posts it is secured to. The posts can lose support due to mechanical contact or from poor installation. Gates can have hinges break off or can be damaged by vehicle traffic. Strand barb wire can come loose due to fence movement.								
Condition Analysis	The fences and gates look in good condition. Some of the barb wire was loose and the south section of the fence appeared to have had some mechanical contact and was not all straight.

Unit Quantity	500 l. ft. (50%)								
Unit Cost Estimate	\$31.50 per l. ft.								
Current Repair or Replacement Cost Estimate	\$15,750								
Estimated Year of Major Repair or Replacement	2035								
Deficiency Analysis	No deficiencies other than the comments above were identified. Funds have been included every 6 years for minor repairs to fences and gates.

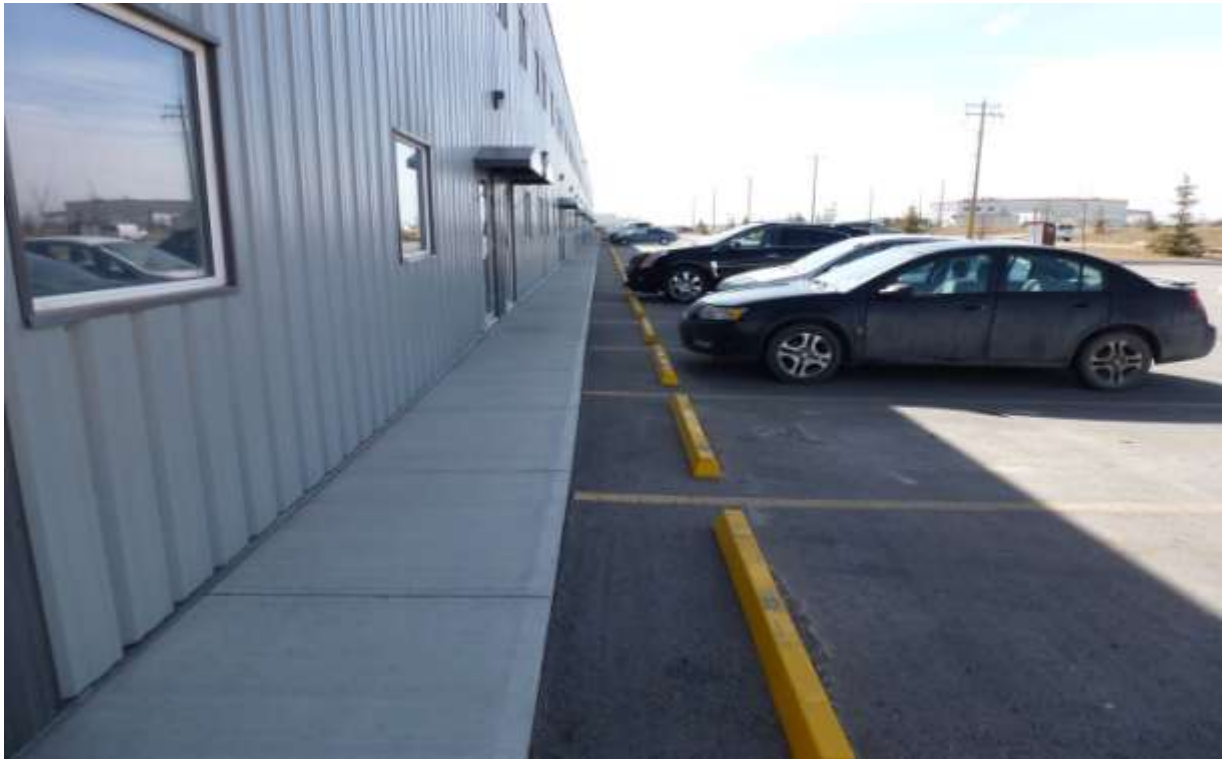
Figure- 10-1

Condition Analysis	The concrete walkway and the concrete spill way were in good condition. The parking barriers are new and were in good condition. Some evidence of vehicle contact and damage to the curbs was noticed at the south entrance.								
Life Cycle Analysis	<table border="0"> <tr> <td>Date of Acquisition:</td> <td>2010</td> </tr> <tr> <td>Normal Life Span</td> <td>25 years</td> </tr> <tr> <td>Effective Age</td> <td>3 years</td> </tr> <tr> <td>Remaining Life Span</td> <td>22years</td> </tr> </table>	Date of Acquisition:	2010	Normal Life Span	25 years	Effective Age	3 years	Remaining Life Span	22years
Date of Acquisition:	2010								
Normal Life Span	25 years								
Effective Age	3 years								
Remaining Life Span	22years								
Unit Quantity And Cost Estimates	<table border="0"> <tr> <td>Unit Quantity</td> <td>500 sq. ft. (20%)</td> </tr> <tr> <td>Unit Cost Estimate</td> <td>\$20.0 per sq. ft.</td> </tr> <tr> <td>Current Repair or Replacement Cost Estimate</td> <td>\$10,000</td> </tr> <tr> <td>Estimated Year of Major Repair or Replacement</td> <td>2035</td> </tr> </table>	Unit Quantity	500 sq. ft. (20%)	Unit Cost Estimate	\$20.0 per sq. ft.	Current Repair or Replacement Cost Estimate	\$10,000	Estimated Year of Major Repair or Replacement	2035

Unit Quantity	500 sq. ft. (20%)								
Unit Cost Estimate	\$20.0 per sq. ft.								
Current Repair or Replacement Cost Estimate	\$10,000								
Estimated Year of Major Repair or Replacement	2035								
Deficiency Analysis	The curbs that are damaged should be repaired over the next few years. Markers identifying curb locations and entrance boundaries can help prevent further damage which often occurs when curbs are hidden by snow. Funds have been included every 6 years for minor repairs.

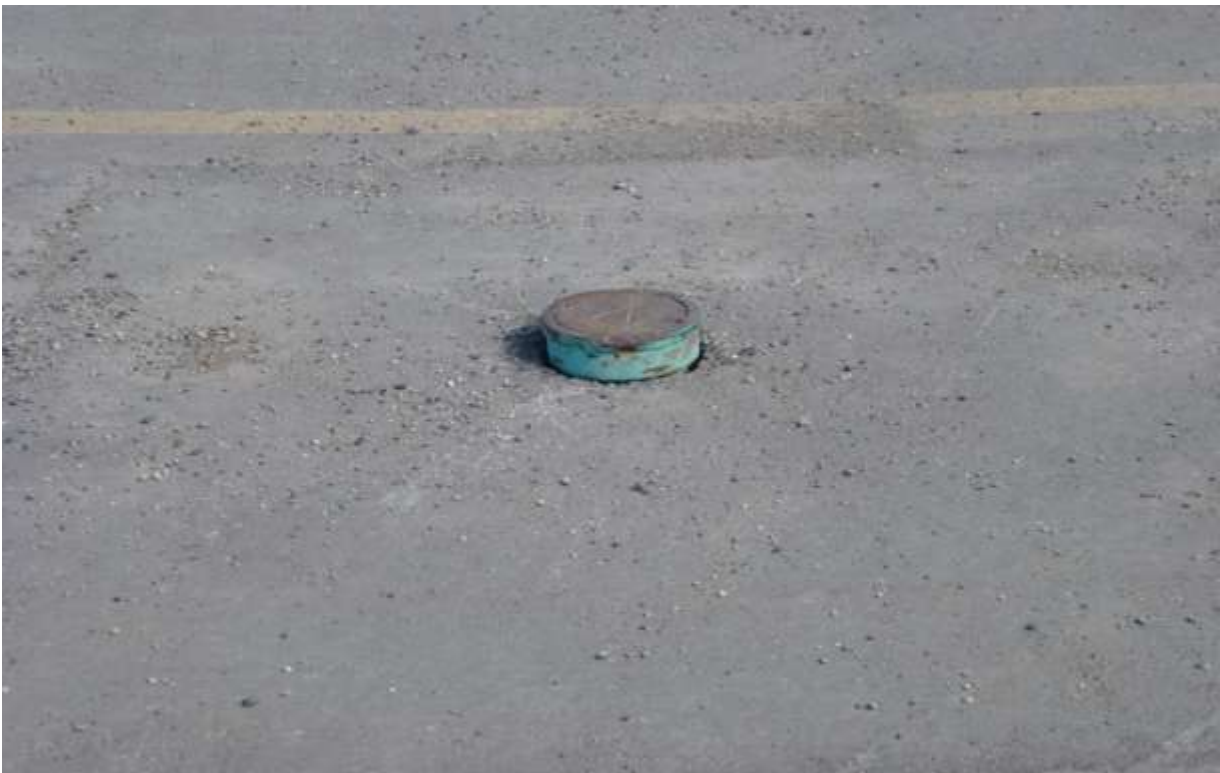
Figure 11-2

Life Cycle Analysis	Date of Acquisition:	2010
	Normal Life Span	25 years
	Effective Age	3 years
	Remaining Life Span	22 years
Unit Quantity And Cost Estimates	Unit Quantity	36,000 sq. ft.
	Unit Cost Estimate	\$1.60 per sq. ft.
	Current Repair or Replacement Cost Estimate	\$57,600
	Estimated Year of Major Repair or Replacement	2035
Deficiency Analysis	Monitor settling and cracks and consider sealing cracks when they occur to extend the life of the asphalt. See comments above regarding additional paving which should be handled by a special assessment if it were to proceed. Funds have been included every 6 years for minor repairs or resealing cracks. Consider some fill around the utility pipe that sticks up in the parking lot and is a potential safety hazard.(See Figure- 11-2)

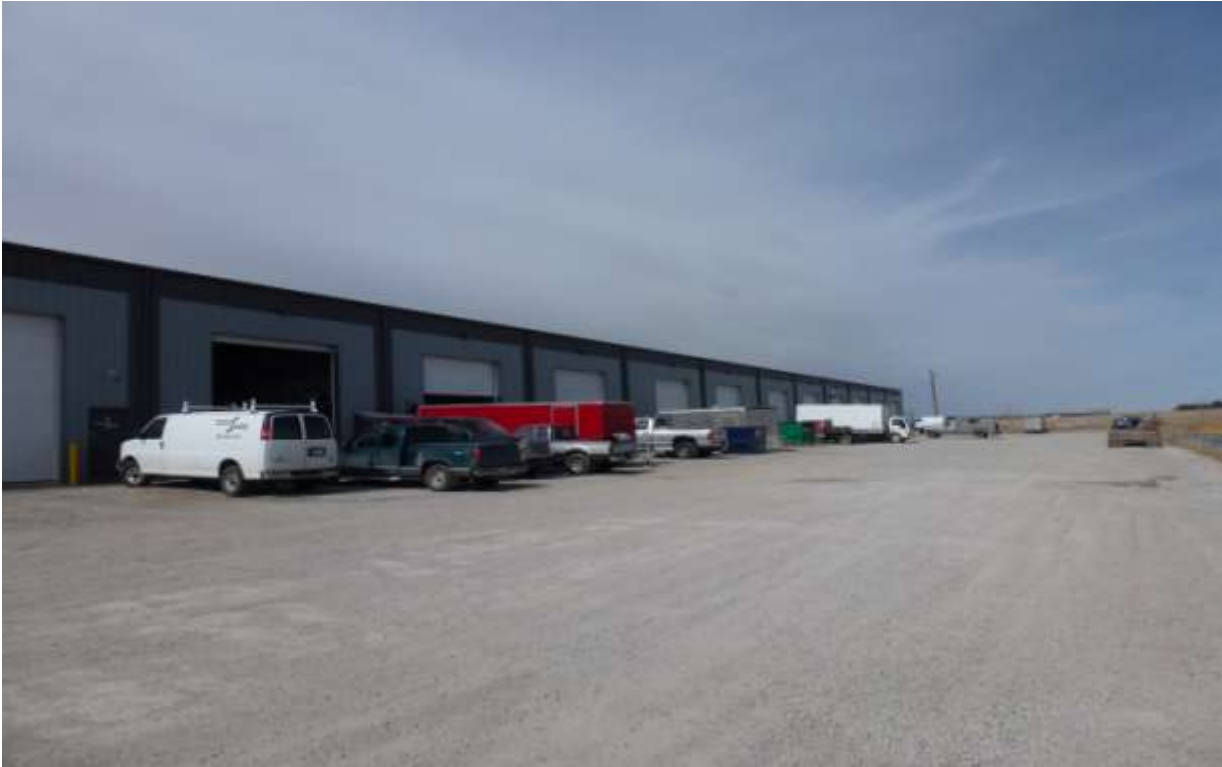
Figure 12-1

Reserve Component: (12) Site Improvements – Gravel Parking Areas		
Physical Description	This component includes the gravel parking area along the south side and at the back of the complex. See Figure 12-1& 12-2	
Financial Analysis	There have been no expenditures on this component to date.	
Potential Deterioration	If the ground settles it may be necessary to grade and re-level the parking area and some new gravel may be required.	
Condition Analysis	The gravel parking area appeared in good condition. Some settling was identified but nothing major.	
Life Cycle Analysis	Date of Acquisition:	2010
	Normal Life Span	10 years
	Effective Age	1 years
	Remaining Life Span	9 years
Unit Quantity And Cost Estimates	Unit Quantity	48,000 sq. ft.
	Unit Cost Estimate	\$0.1 per sq. ft.
	Current Repair or Replacement Cost Estimate	\$4,800
	Estimated Year of Major Repair or Replacement	\$1000 every second year
Deficiency Analysis	Monitor settling and re-grade and fill with gravel as required.

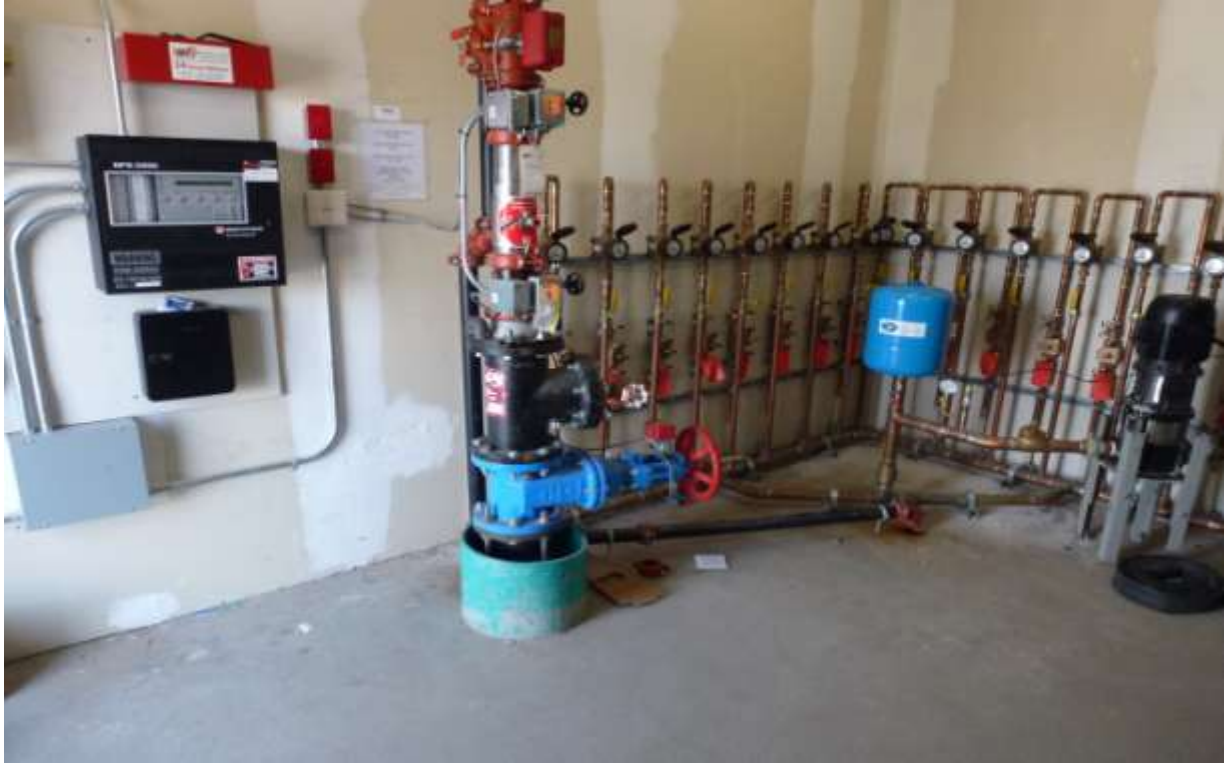
Figure 13-1

Condition Analysis	Most of the site services are not visible. Where viewing was possible equipment appeared in good condition.	
Life Cycle Analysis	Date of Acquisition:	2010
	Normal Life Span	15 years
	Effective Age	3 years
	Remaining Life Span	12years
Unit Quantity And Cost Estimates	Unit Quantity	Allowance
	Unit Cost Estimate	\$25,000
	Current Repair or Replacement Cost Estimate	\$25,000
	Estimated Year of Major Repair or Replacement	2025
Deficiency Analysis	No deficiencies were identified with this component. Timing of the above is at best an estimate with actual expenditures to be expected both before and after the above date. The above amount is simply a contingency to ensure that funds are available. Ensure the mechanical contractor does annual inspections of the backflow prevention device on the water intake system.

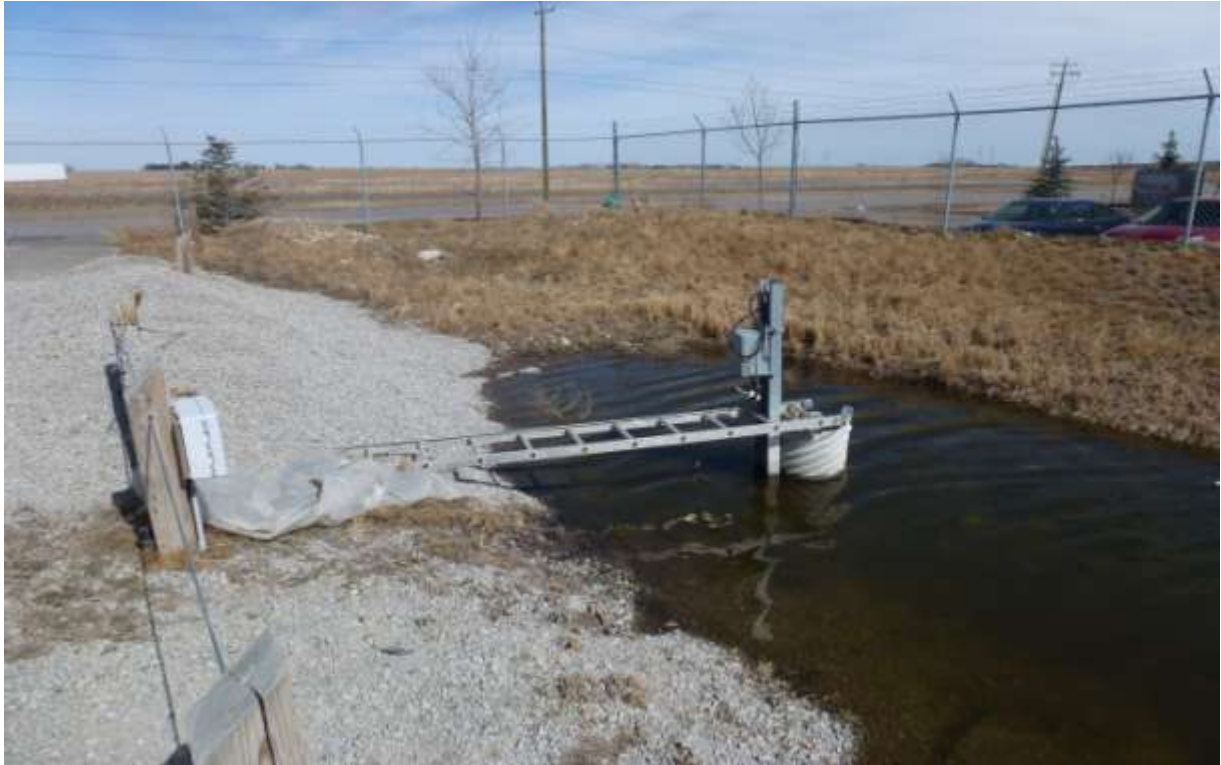
Figure 14-1

Reserve Component: (14) Site Improvements – Landscaping& Irrigation		
Physical Description	This component includes all exterior landscaping and irrigation It includes any retaining walls as well as the cable retaining barrier at the back of the complex next to the irrigation canal. See Figure 14-1& 14-2	
Financial Analysis	There have been no expenditures on this component to date	
Potential Deterioration	Trees may require pruning or replacement. The irrigation pump may require replacement. Irrigation piping may require replacing. Retaining walls and barriers may require repair due to mechanical contact or from settling issues.	
Condition Analysis	Landscaping was in good condition. It looked like there may be a few trees that may require replacing. There was mention that the irrigation pump may be relocated but after discussion with the board it was not included in this report as it would most likely be a maintenance issue.

Life Cycle Analysis	Date of Acquisition:	2010
	Normal Life Span	10 years
	Effective Age	3 year
	Remaining Life Span	7 year
Unit Quantity And Cost Estimates	Unit Quantity	Allowance
	Unit Cost Estimate	\$10,000
	Current Repair or Replacement Cost Estimate	\$10,000
	Estimated Year of Major Repair or Replacement	2020
Deficiency Analysis	There were no observed deficiencies with this component other than the comments made above..
