RESERVE FUND STUDY

FRONTIER BUSINESS PARK
CONDOMINIUM CORPORATION # 1010603
240040 FRONTIER PLACE
ROCKY VIEW COUNTY, ALBERTA

APRIL, 2018

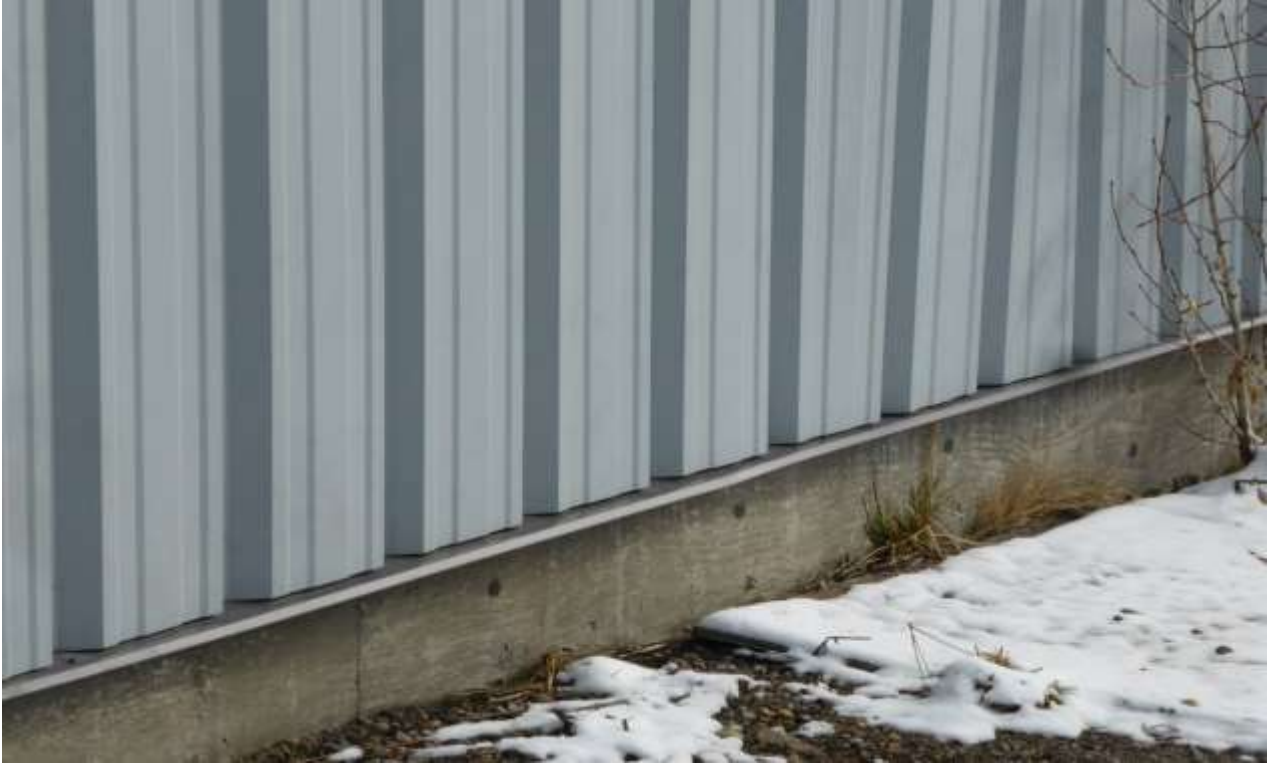
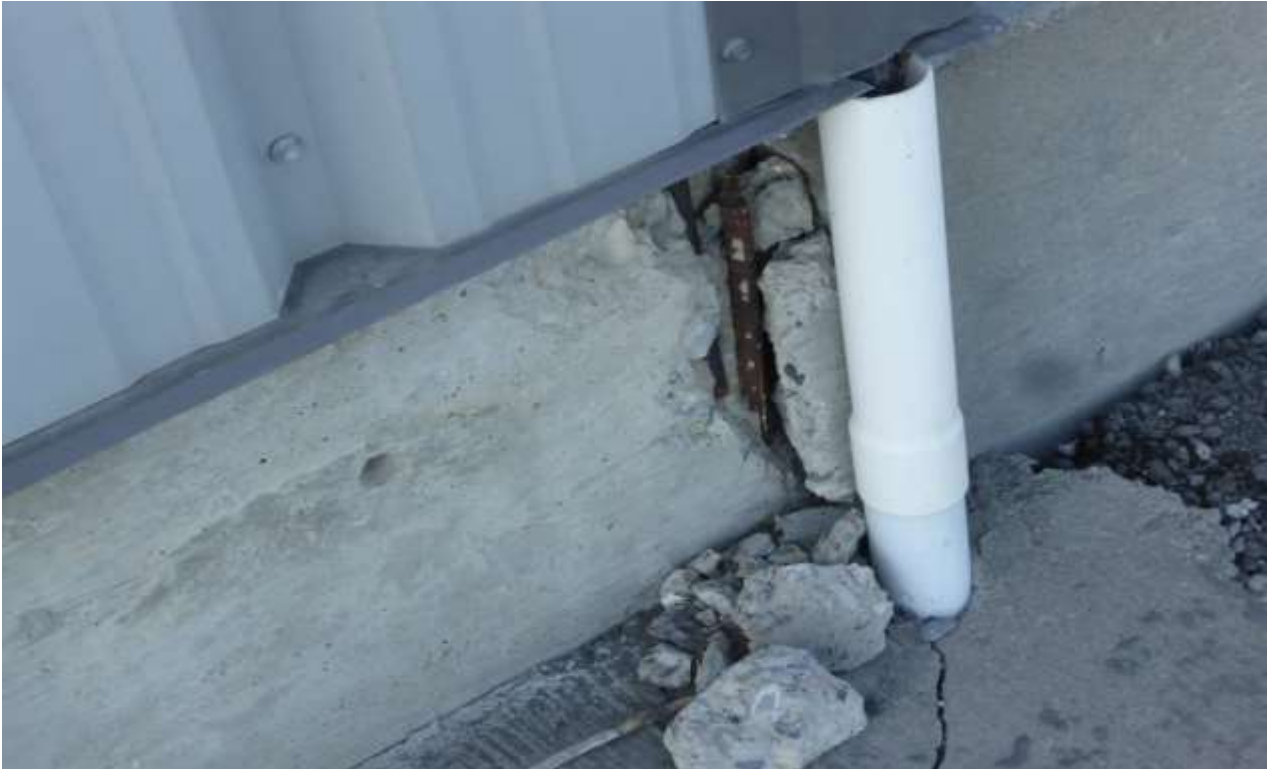
Reserve Component: (1) Building – Foundations		
Physical Description	This component includes all foundations. This is a contingency to allow for funds for an Engineering report should there be any foundation or building envelope issues in future years. See Figure 1-1 & 1-2.	
Financial Analysis	This component has had no recorded expenditures in the last 3 years.	
Potential Deterioration	Potential deterioration includes cracking due to settling or from moisture infiltration. Water proofing if not properly installed will separate from the concrete and allow moisture to get through to the concrete leading to further deterioration.	
Condition Analysis	There were no observed major issues with the building foundations.	
Life Cycle Analysis	Date of Acquisition	2010
	Normal Life Span	25 Years
	Effective Age	9 Years
	Remaining Life Span	16 Years
Unit Quantity And Cost Estimates	Unit Quantity	Allowance
	Unit Cost Estimate	\$10,000

Current Repair or Replacement Cost Estimate	\$10,000
	Estimated Year of Major Repair or Replacement	2030/35/40
Deficiency Analysis	There were no deficiencies identified with this component.

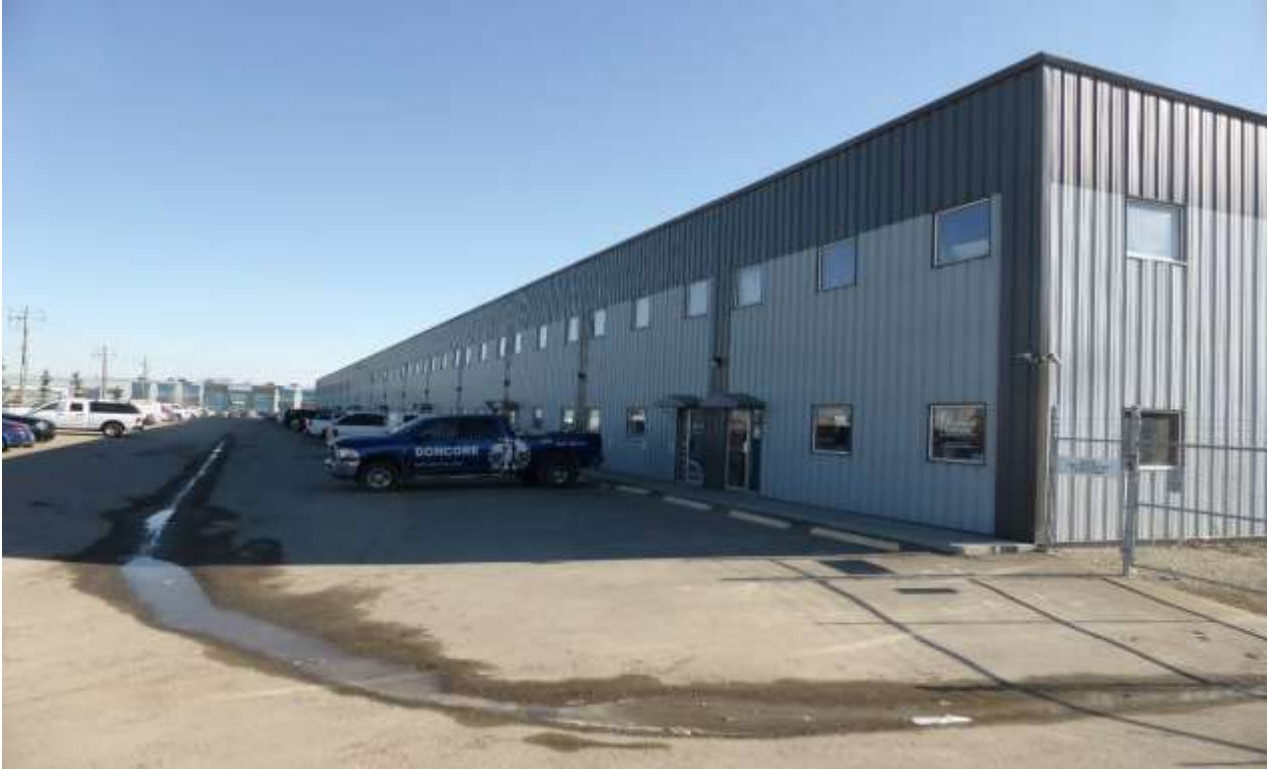
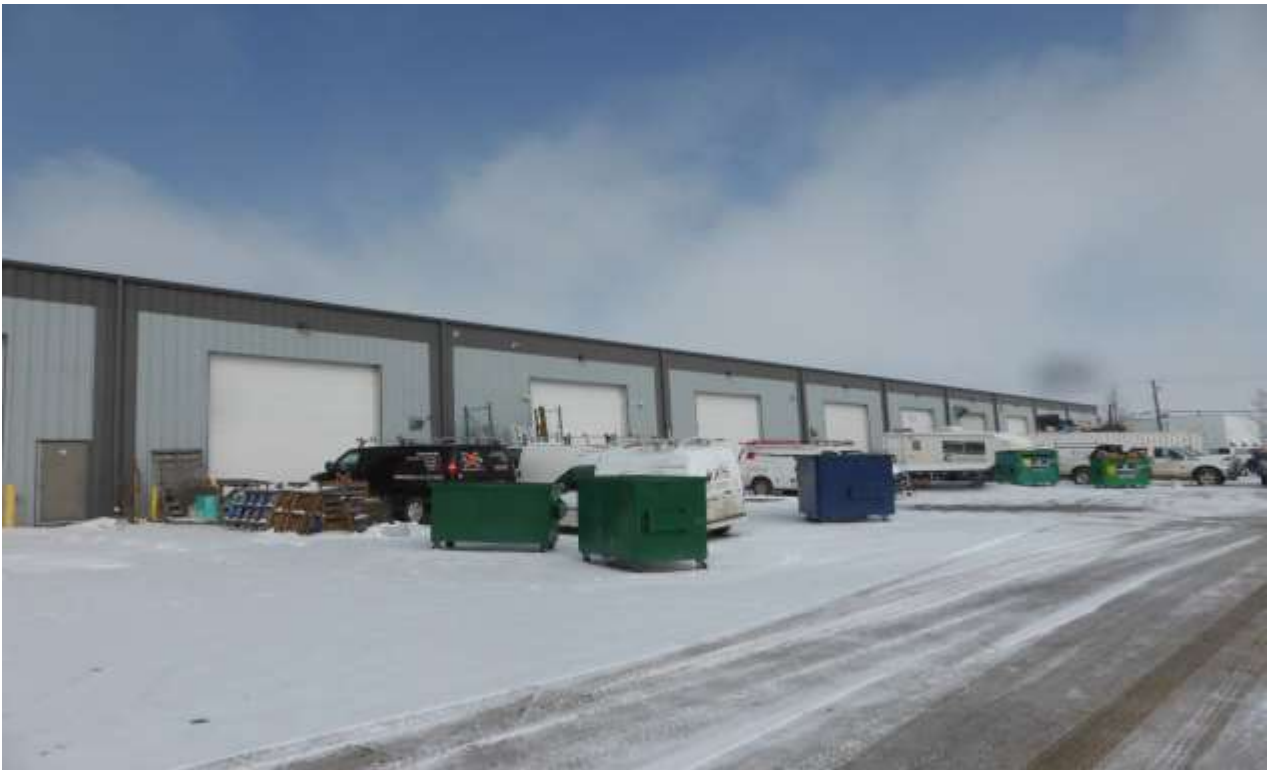
Reserve Component: (2) Building – Metal Walls & Roof- Repairs		
Physical Description	This component includes repairs only to the metal building walls and roof as well as the one common metal door accessing the utility room. It also includes repairs to the canopies which were installed over the front entrance doors. Component replacement is beyond the 25-year review period. See Figure 2-1 & 2-2.	
Financial Analysis	There have been no expenditures on this component in the last 3 years. The canopies were installed in 2011/12 for a cost of \$9,360.	
Potential Deterioration	Metal surfaces can be dented by mechanical contact. Screws used to secure the metal can come loose or require replacement over time. The metal roof may require repairs associated with holes or protrusion for equipment or from heavier items being moved over it. The metal utility room door may require repairs as could the canopies over the doors.

Condition Analysis	The metal roof and walls were in good condition. The utility room door and canopies were in good condition with no issues identified.	
Life Cycle Analysis	Date of Acquisition	2010
	Normal Life Span	25 Years (Repair)
	Effective Age	9 Years
	Remaining Life Span	16 Years
Unit Quantity And Cost Estimates	Unit Quantity	Allowance
	Unit Cost Estimate	\$20,000
	Current Repair or Replacement Cost Estimate	\$20,000
	Estimated Year of Major Repair or Replacement	2025/30/35
Deficiency Analysis	Funds have been included for a roof inspection and repairs every 5 years starting in 2025.

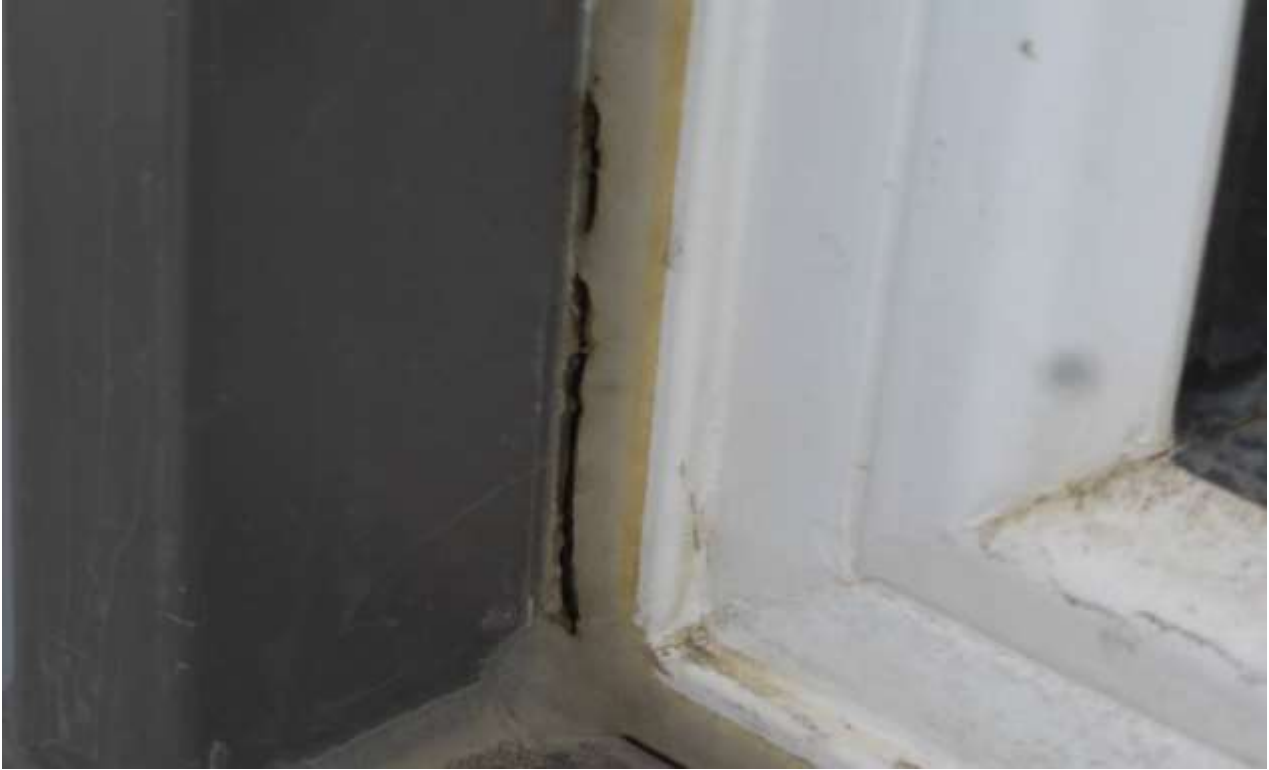
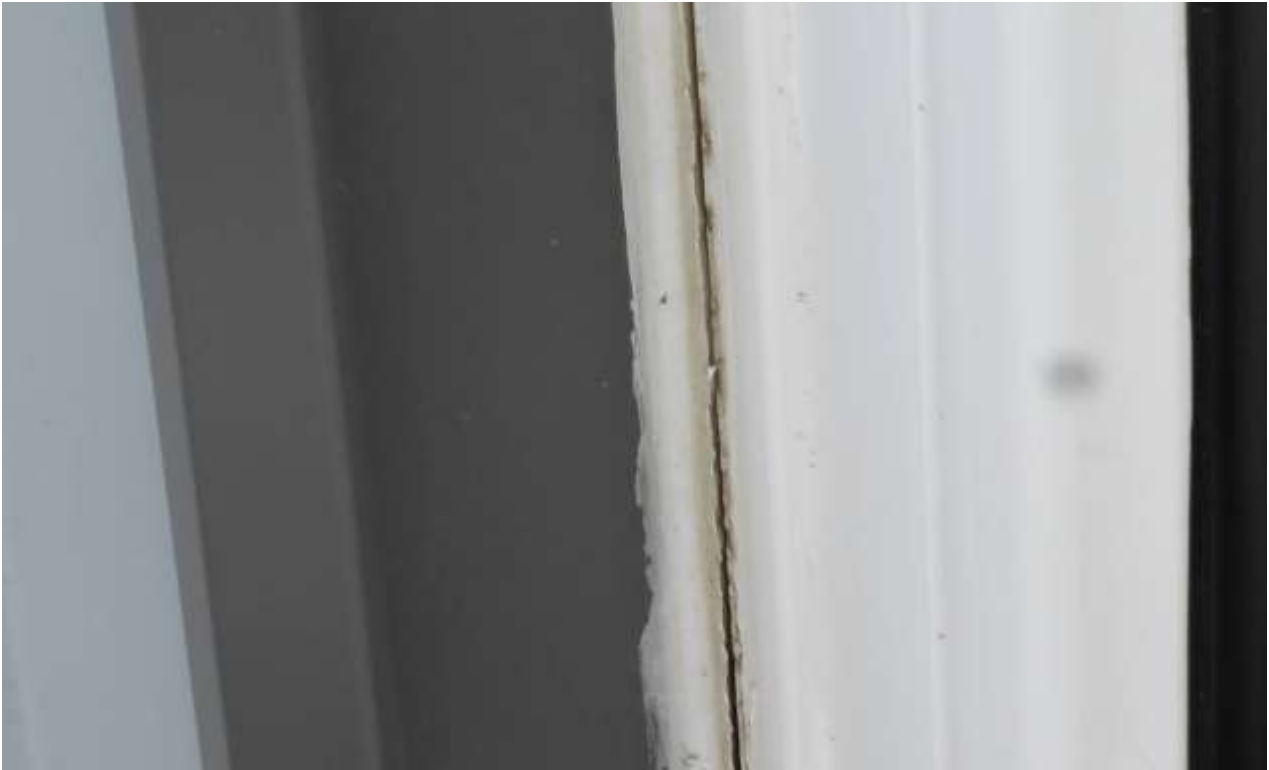
Reserve Component: (3) Building – Caulking		
Physical Description	This component includes caulking around all windows, doors, protrusions and joints between dissimilar materials. Even though windows and doors are owner responsibility the caulking around them is the responsibility of the Condominium Corporation. See Figure 3-1& 3-2.	
Financial Analysis	There have been no expenditures on this component in the last 3 years.	
Potential Deterioration	Caulking breaks down over time and becomes hard leading to cracking and shrinkage. If the seal is broken moisture infiltration may occur causing significant damage to the building envelope.	
Condition Analysis	The caulking appeared to be in average condition where it could be accessed and inspected. The caulking was starting to dry out and crack on some windows viewed.	
Life Cycle Analysis	Date of Acquisition	2010
	Normal Life Span	15 Years
	Effective Age	10 Years

Remaining Life Span	5 Years
Unit Quantity And Cost Estimates	Unit Quantity	Allowance
	Unit Cost Estimate	\$10,000
	Current Repair or Replacement Cost Estimate	\$10,000
	Estimated Year of Major Repair or Replacement	2024
Deficiency Analysis	Areas with cracked caulking should be repaired prior to a more major replacement in 5 years. Make sure all protrusions through the roof are checked for proper caulking as part of the roof inspection.

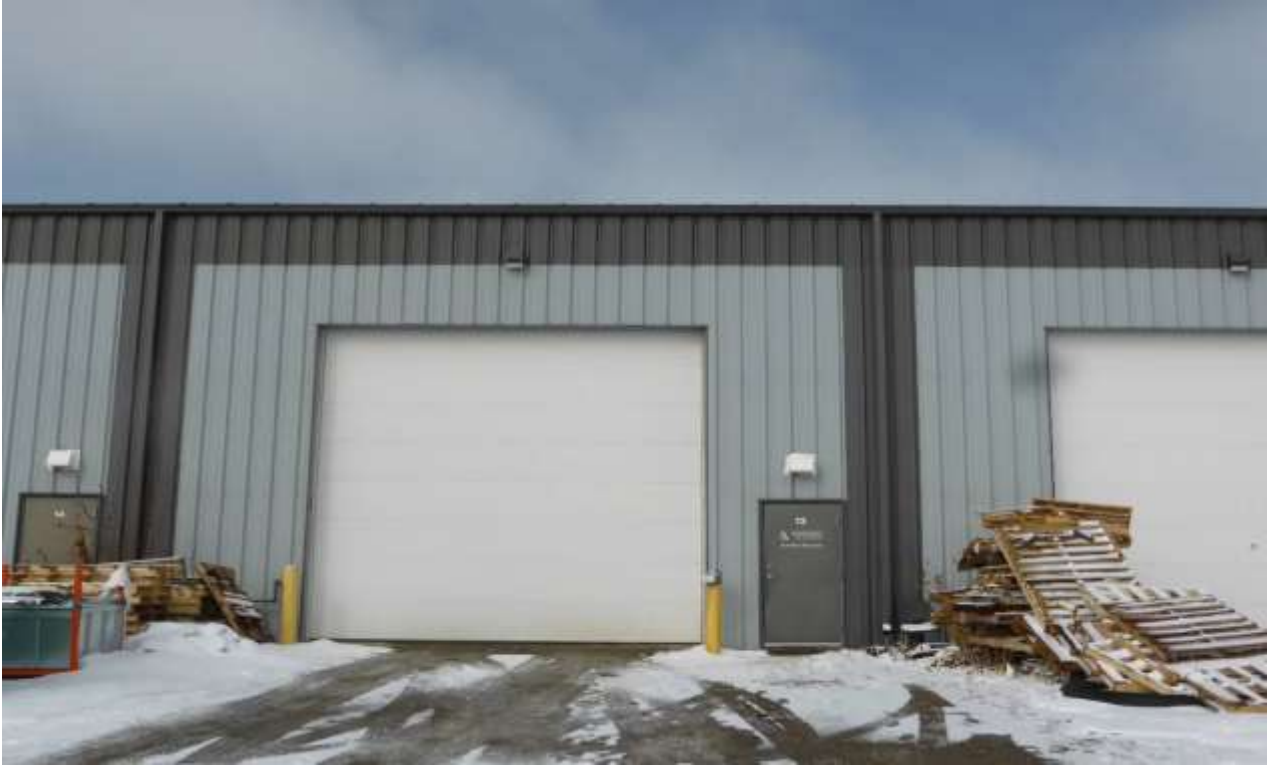
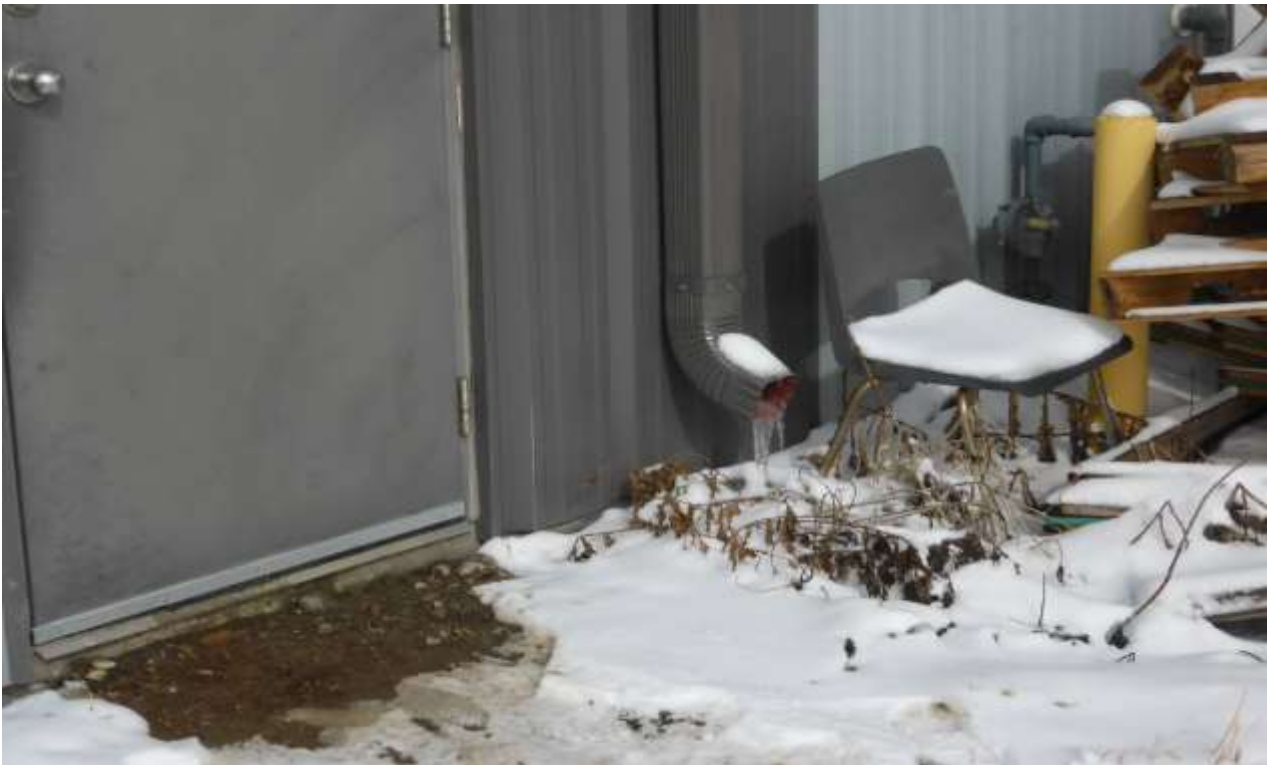
Reserve Component: (4) Building – Eavestroughs & Downspouts		
Physical Description	This component includes the repairs and replacements as required to the eavestroughs and downspouts. Full replacement should not be required over the 25- year review period. See Figure 4-1 & 4-2.	
Financial Analysis	There have been no expenditures on this component in the last 3 years.	
Potential Deterioration	Metal eavestroughs can come loose from the area they are secured to. They can be bent or broken by contact with equipment used for landscaping. Ice buildup and freezing can cause damage. The eavestroughs and downspouts can develop leaks and can also fade. Connection joints may require caulking.	
Condition Analysis	The eavestroughs and downspouts appeared to be in good condition.	
Life Cycle Analysis	Date of Acquisition	2010
	Normal Life Span	25 Years
	Effective Age	9 Years
	Remaining Life Span	16 Years
Unit Quantity And Cost Estimates	Unit Quantity	Allowance

Unit Cost Estimate	\$5,000
	Current Repair or Replacement Cost Estimate	\$5,000
	Estimated Year of Major Repair or Replacement	2035
Deficiency Analysis	There were no deficiencies identified with this component.

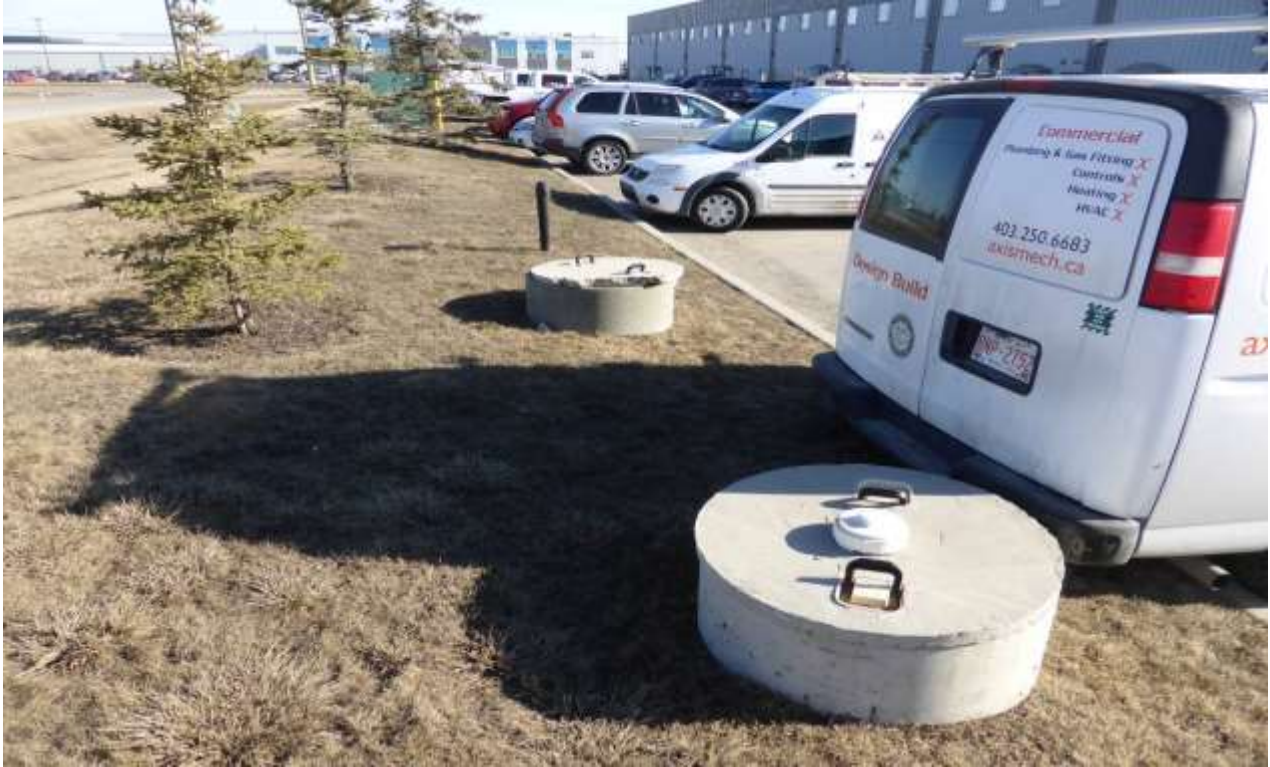
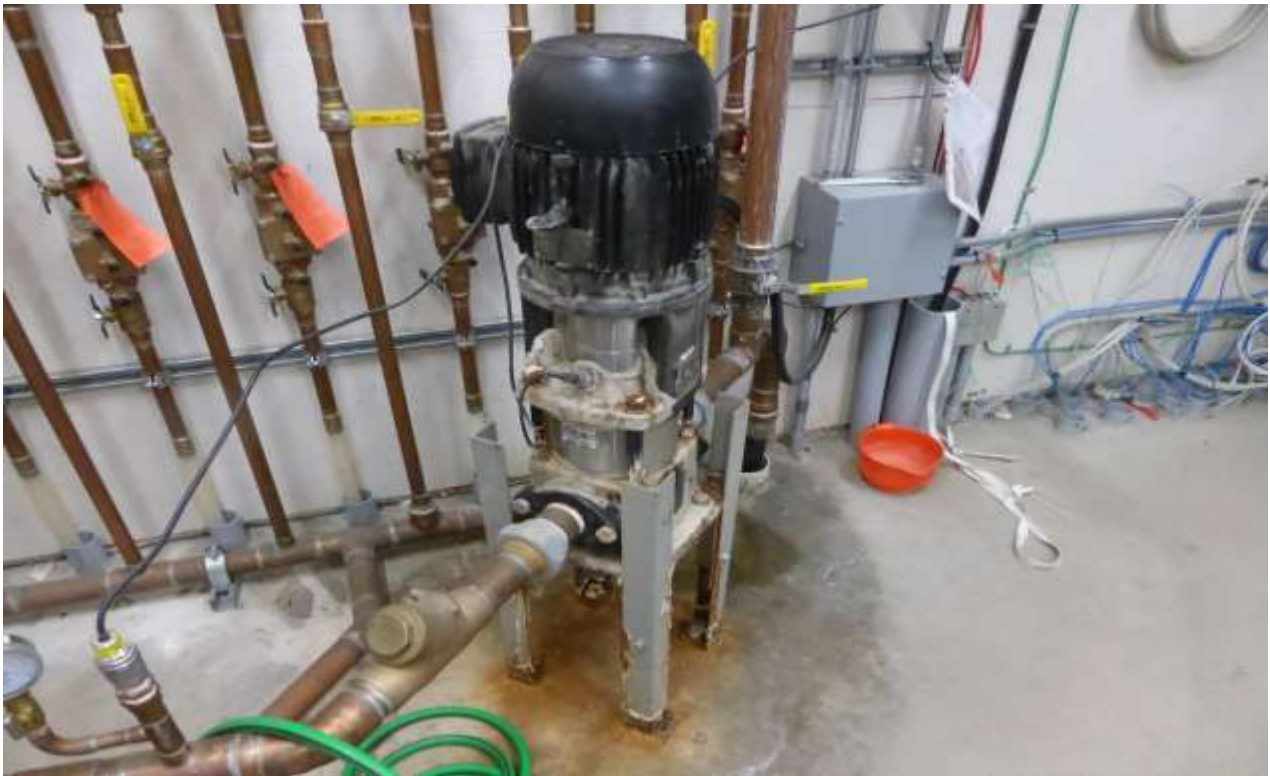
Reserve Component: (5) Mechanical & Electrical- Water & Sewer System		
Physical Description	This component includes the repairs and replacement of the self-contained water and sewer system for this condominium complex. It includes the underground water and sewer tanks, charge pump, surge tank and all piping to and from the tankage. Everything that would become redundant when connected to the city services is included. See Figure 5-1 & 5-2.	
Financial Analysis	There have been no expenditures on this component in the last three years.	
Potential Deterioration	Underground storage tanks can develop leaks. Underground piping can fail. Charge pumps and controls may require repair or replacement.	
Condition Analysis	The water and sewer system appeared to be in good condition. The charge pump showed evidence of leaking and the motor was very noisy when inspected. There were some gaps on the top of the water tank man cover from usage and breakage. There was an open coupling on the top of the sewer tank that should have a plug in it.

Life Cycle Analysis	Date of Acquisition	2010
	Normal Life Span	15 Years
	Effective Age	9 Years
	Remaining Life Span	6 Years
Unit Quantity And Cost Estimates	Unit Quantity	Allowance
	Unit Cost Estimate	\$15,000
	Current Repair or Replacement Cost Estimate	\$15,000
	Estimated Year of Major Repair or Replacement	2020/25
Deficiency Analysis	See comments above. Funds have been included to replace the charge pump and motor in 2020. Actual timing could vary.

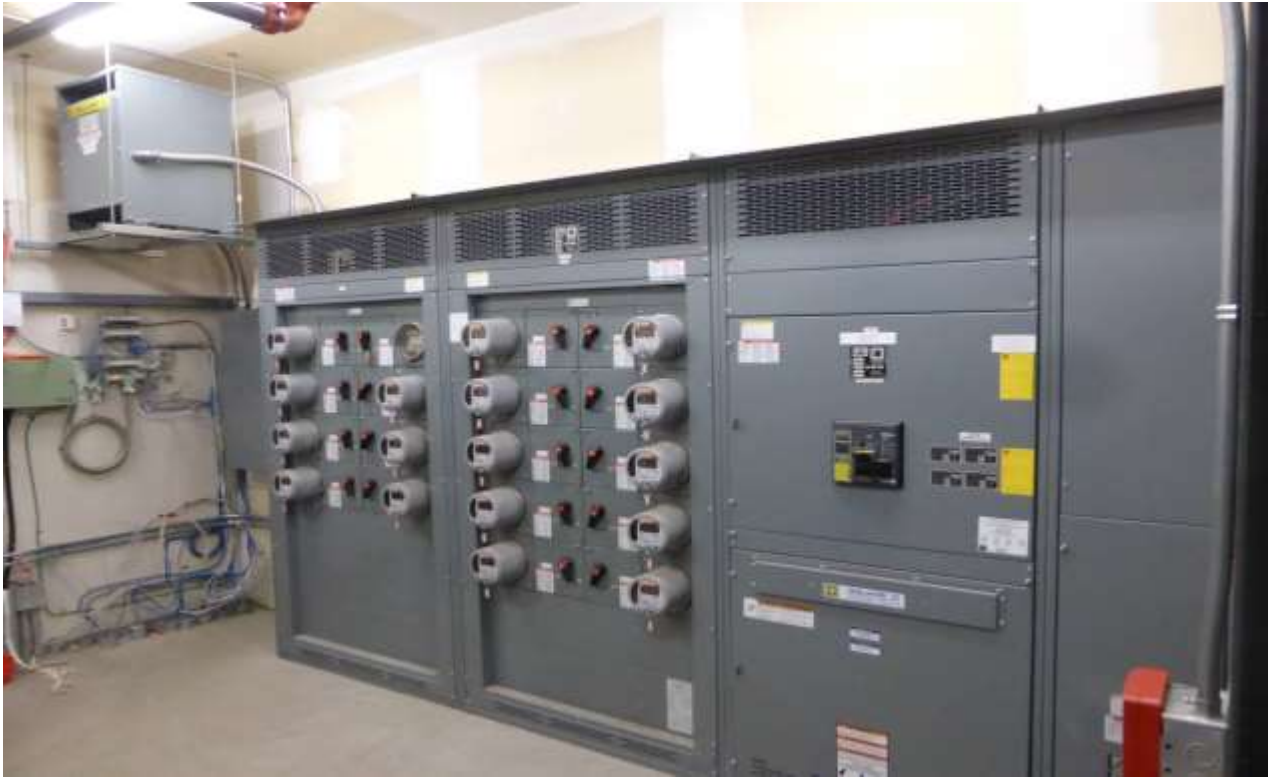
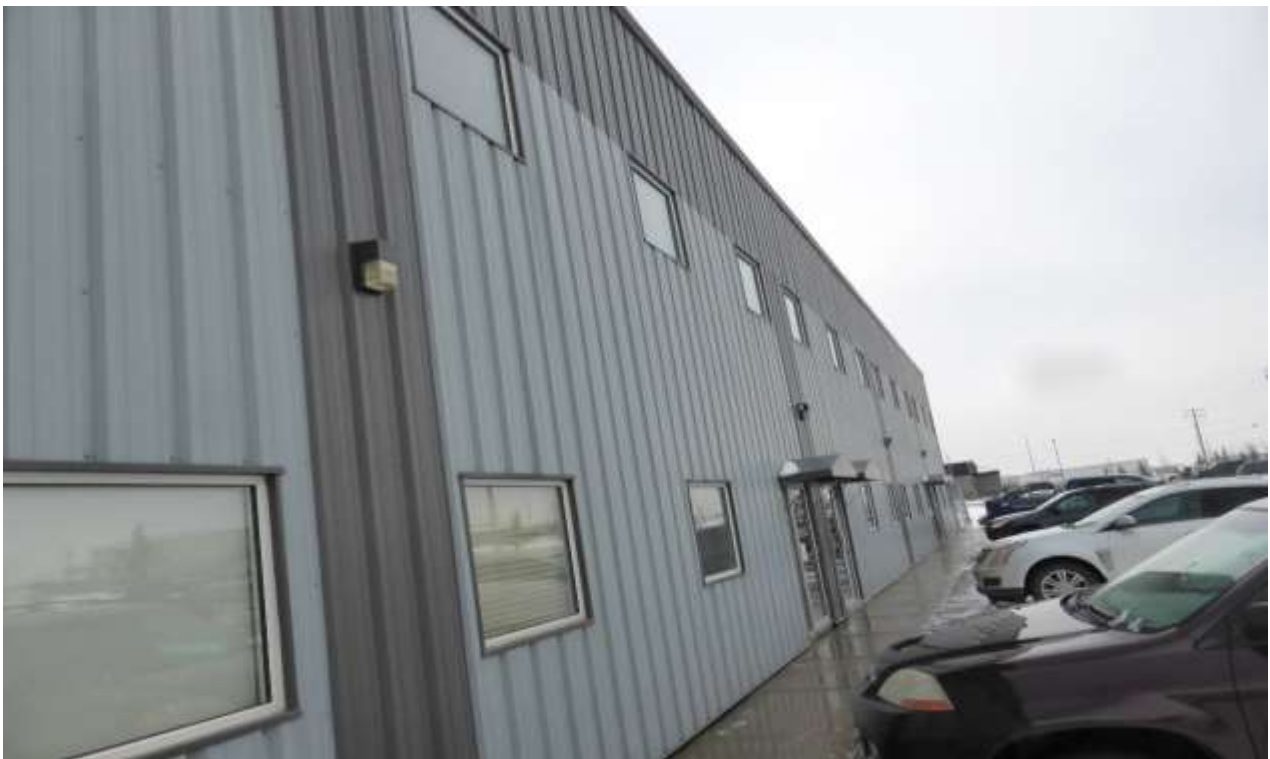
Reserve Component: (6) Mechanical & Electrical – Electrical & Lighting		
Physical Description	This component includes all the electrical switch gear, panels, transformers and wiring. It includes the telephone, cable and all lighting inside the utility room. It includes the electric space heater in the utility room as well as the outside lighting. This is an allowance to allow for any major repairs that may arise over time. See Figure 6-1 & 6-2.	
Financial Analysis	There have been no expenditures on this component in the last 3 years. Exterior lights are being changed over to LED as they burn out and this is being done as part of general maintenance.	
Potential Deterioration	Most electrical should be maintenance free. Code changes can require upgrades to panels and wiring. Electrical lighting becomes dated and is usually changed out for visual reasons or better technology. Electrical heaters can fail and require replacement.

Condition Analysis	There were no issues identified with this component.	
Life Cycle Analysis	Date of Acquisition	2010
	Normal Life Span	20 Years
	Effective Age	9 Years
	Remaining Life Span	11 Years
Unit Quantity And Cost Estimates	Unit Quantity	Allowance
	Unit Cost Estimate	\$15,000
	Current Repair or Replacement Cost Estimate	\$15,000
	Estimated Year of Major Repair or Replacement	2025/30/35
Deficiency Analysis	There were no deficiencies identified with this component.

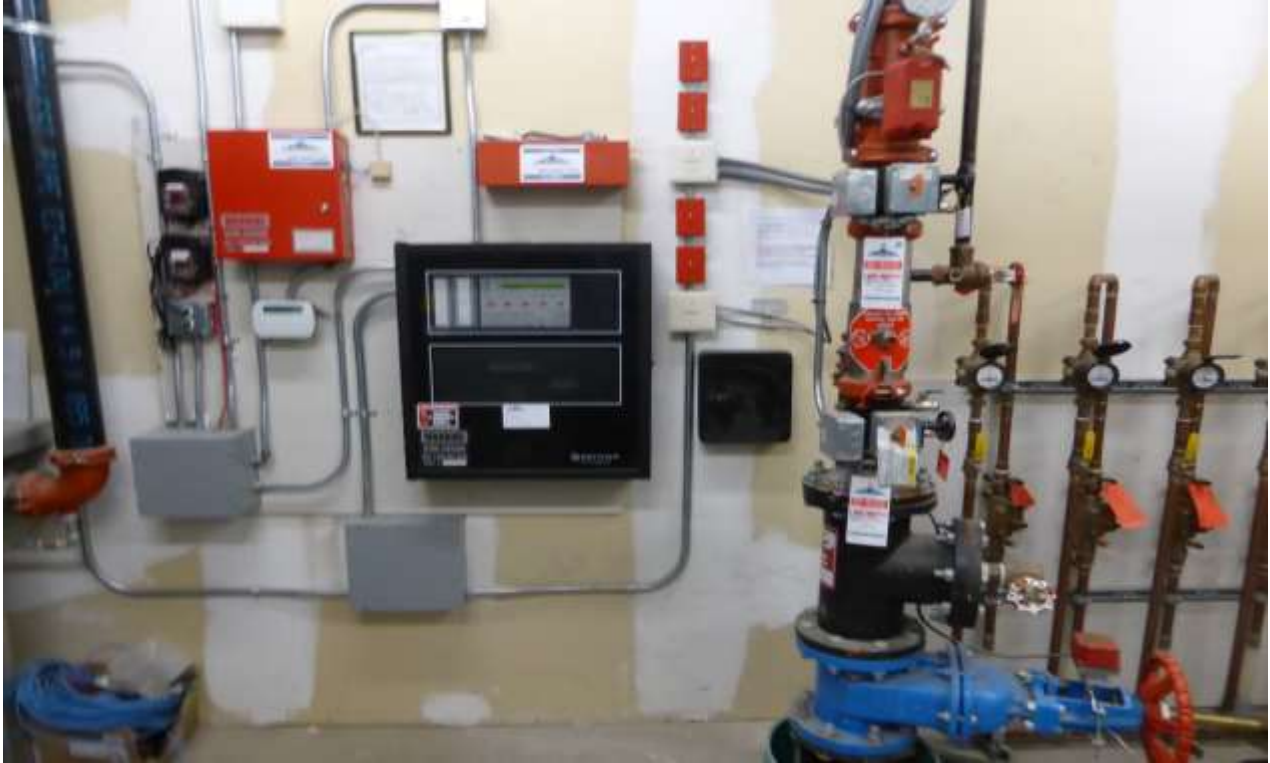
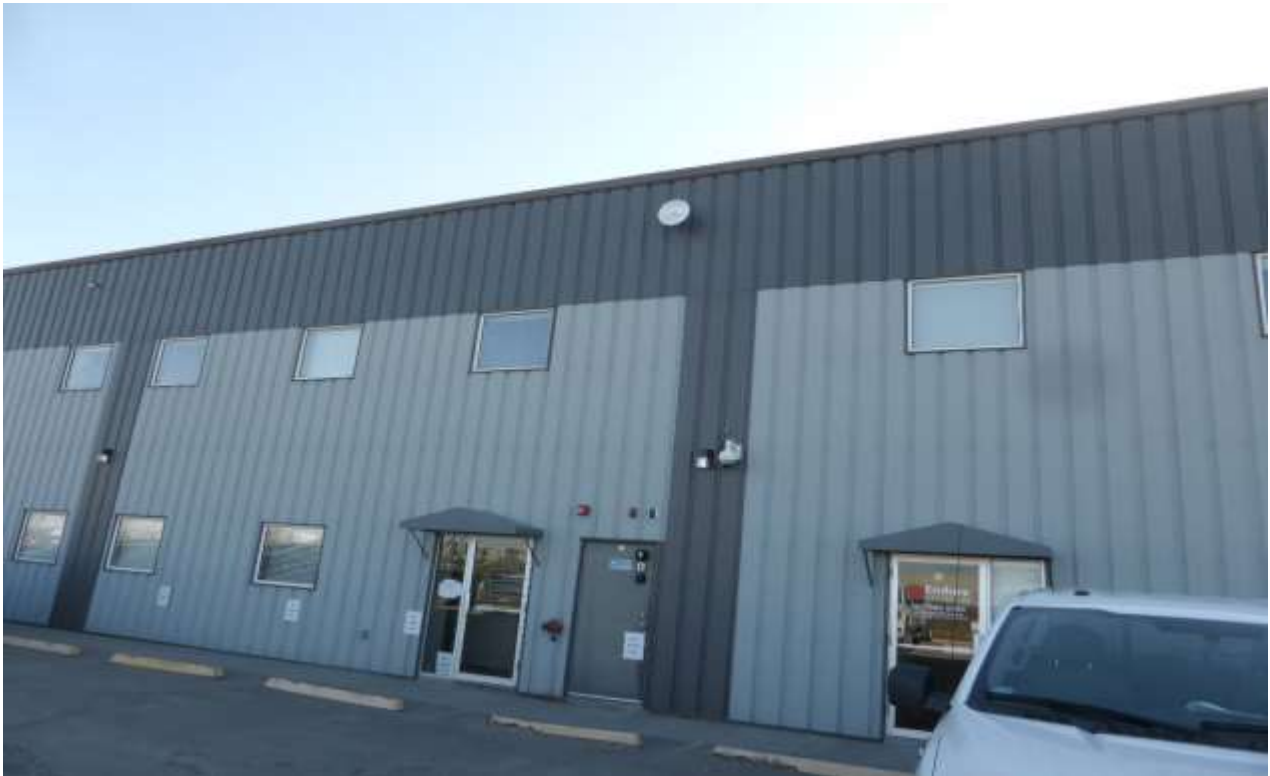
Reserve Component: (7) Mechanical & Electrical – Callout/Security System		
Physical Description	This component includes the automated call out system that is triggered by the fire alarm panel. It also includes the local alarm that is used for the water and sewer system. See Figure 7-1 & 7-2.	
Financial Analysis	There have been no expenditures on this component in the last three years.	
Potential Deterioration	Callout systems should be relatively maintenance free. These systems are usually changed out as part of a building upgrade or if technology makes them obsolete.	
Condition Analysis	The callout system was reported to be functioning okay with no issues identified.	
Life Cycle Analysis	Date of Acquisition	2010
	Normal Life Span	20 Years
	Effective Age	9 Years
	Remaining Life Span	11 Years
Unit Quantity And Cost Estimates	Unit Quantity	Allowance
	Unit Cost Estimate	\$5,000
	Current Repair or Replacement Cost Estimate	\$5,000

Estimated Year of Major Repair or Replacement	2030
Deficiency Analysis	There were no deficiencies identified with this component.

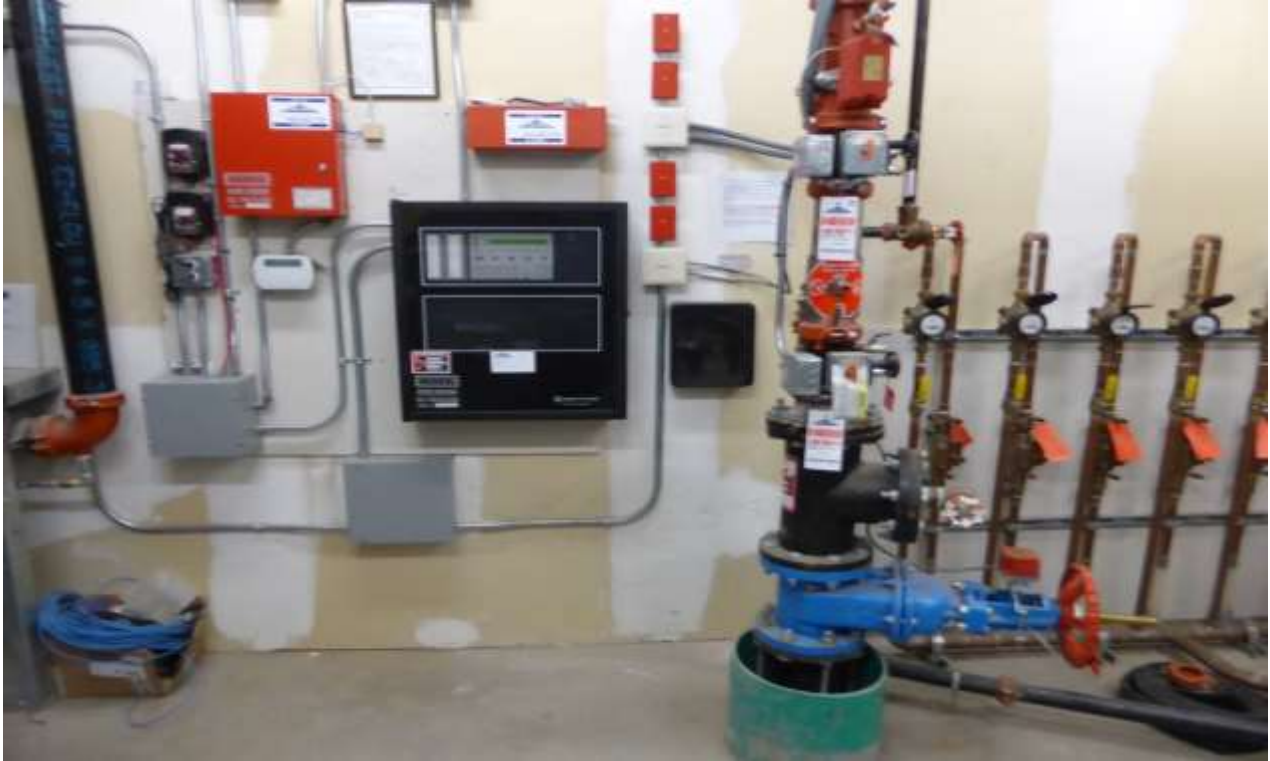
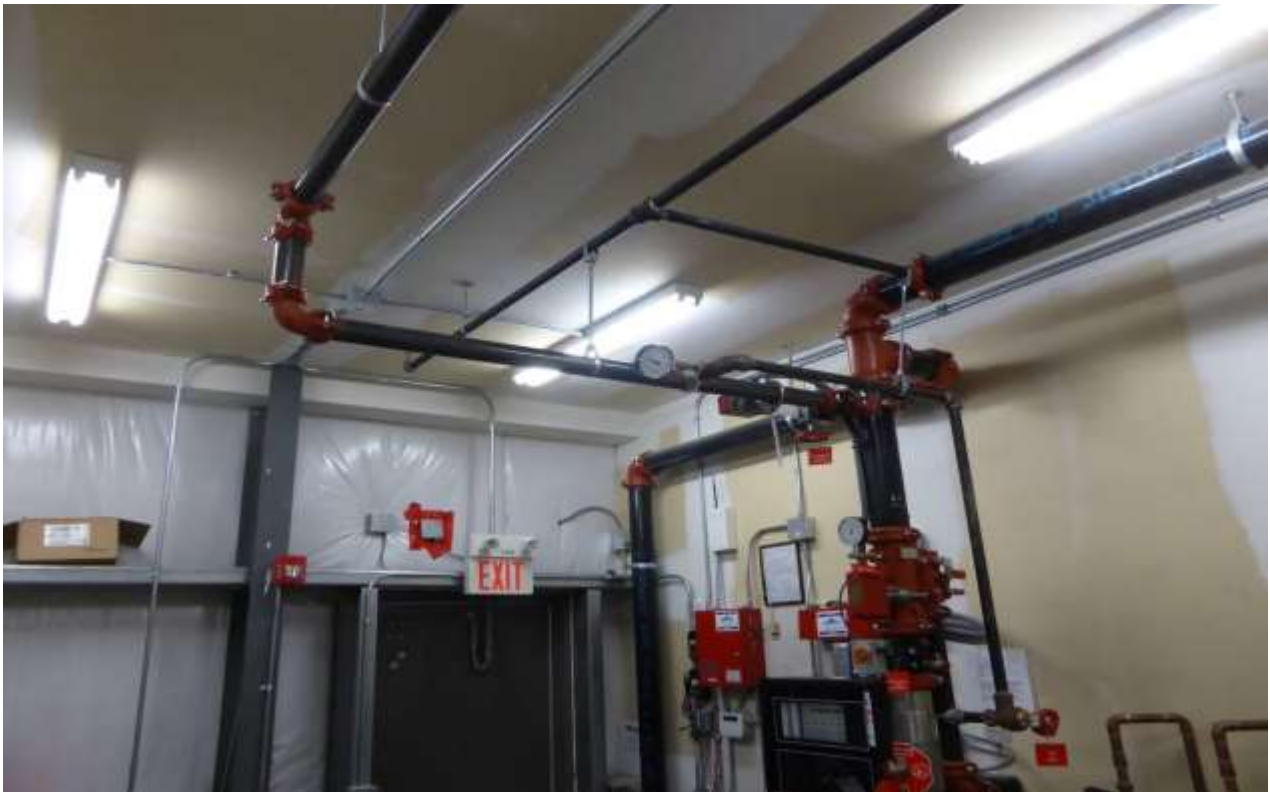
Reserve Component: (8) Mechanical & Electrical – Fire Alarm System		
Physical Description	This component includes the fire alarm panel and all related interconnections from this equipment. See Figure 8-1 & 8-2.	
Financial Analysis	There have been no expenditures on this component in the last three years.	
Potential Deterioration	Fire alarm panels need to be routinely serviced. Fire requirements and codes change making older systems obsolete.	
Condition Analysis	There were no issues identified with this component.	
Life Cycle Analysis	Date of Acquisition	2010
	Normal Life Span	20 Years
	Effective Age	9 Years
	Remaining Life Span	11 Years
Unit Quantity And Cost Estimates	Unit Quantity	Allowance
	Unit Cost Estimate	\$5,000
	Current Repair or Replacement Cost Estimate	\$5,000
	Estimated Year of Major Repair or Replacement	2030
Deficiency Analysis	No deficiencies were identified with this component. Maintain annual inspections and carried out any repairs recommended.

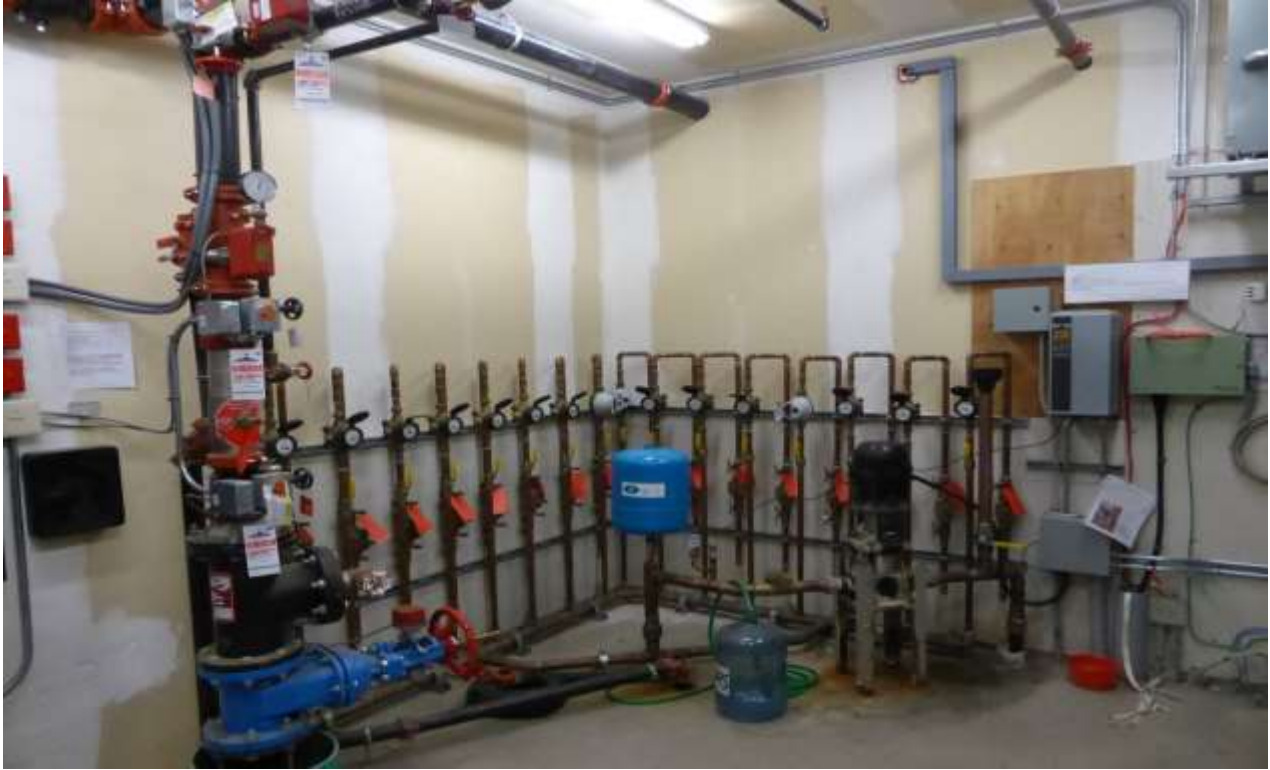
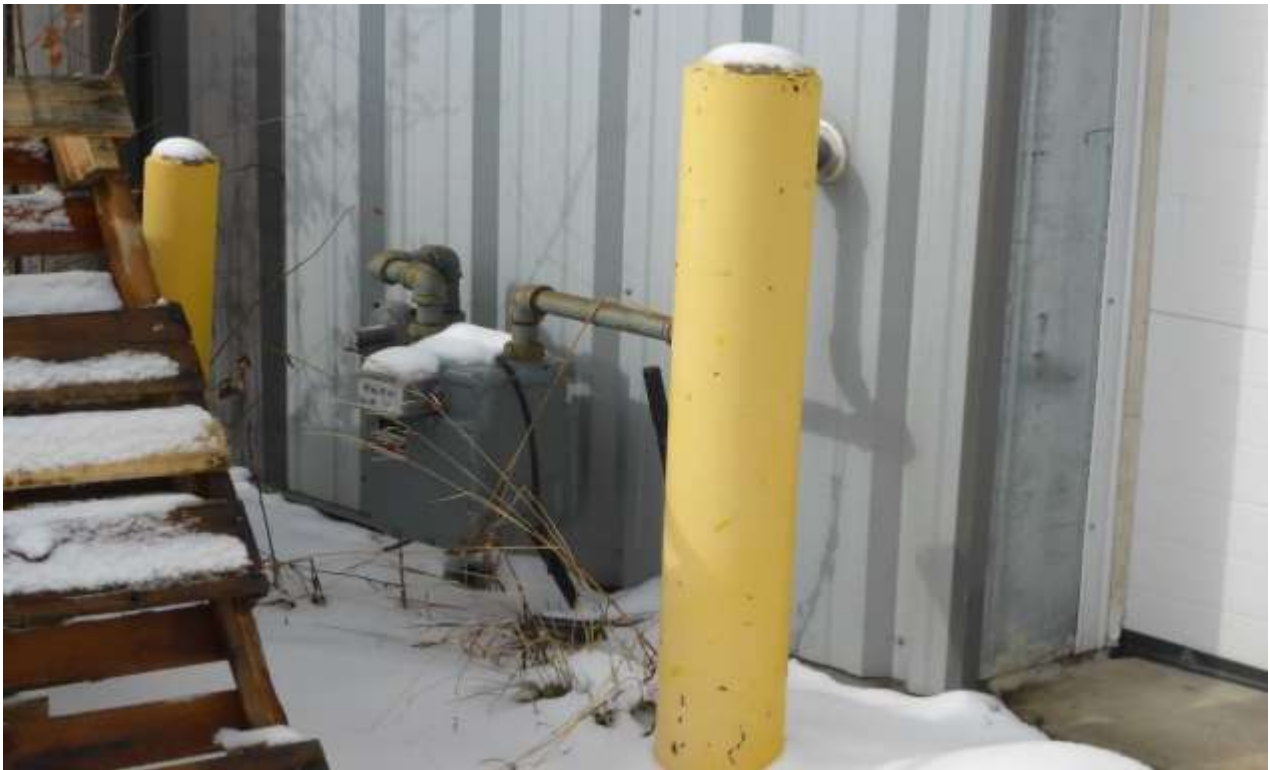
Reserve Component: (9) Site Improvements – Site Services		
Physical Description	This component is a contingency for replacement of underground water, sewer, natural gas lines and all related piping and valves providing service on site prior to the point of distribution to individual units. It includes all the firewater system, valves, standpipes and the sprinkler system. It includes the backflow prevention devices. See Figure 9-1 & 9-2.	
Financial Analysis	There have been no expenditures on this component in the last three years.	
Potential Deterioration	Water and sewer is localized at this facility and is covered by a separate component through to the main distribution and collection points. This component includes the common distribution of water and sewer throughout the complex. Natural gas is provided individually to each unit and is the individual owners responsibility. The fire water system is common property. Piping for these items from the mechanical room through the building and back is considered common property and the condominium responsibility. Vales and piping can leak. The firewater valves may require replacement. Settling can cause lines to break and require servicing. Sprinkler heads may require repair or replacement. Most of the equipment should last the life of the facility and this is simply a contingency for any minor failure that may occur.

Condition Analysis	Most of the site services are not visible. Where viewing was possible equipment appeared in good condition. There was mention of sediment being identified in the sprinkler system in a couple of locations.	
Life Cycle Analysis	Date of Acquisition	2010
	Normal Life Span	20 Years
	Effective Age	9 Years
	Remaining Life Span	11 Years
Unit Quantity And Cost Estimates	Unit Quantity	Allowance
	Unit Cost Estimate	\$30,000
	Current Repair or Replacement Cost Estimate	\$30,000
	Estimated Year of Major Repair or Replacement	2023/26/29
Deficiency Analysis	See comments above. Timing of future costs for this component is at best an estimate with actual timing to vary. The above amount is simply a contingency to ensure funds are available. During the next annual inspection of the fire control system have them check for sediment in the lines.
