RESERVE FUND STUDY

FRONTIER BUSINESS PARK
CONDOMINIUM CORPORATION # 1010603
240040 FRONTIER PLACE
ROCKY VIEW COUNTY, ALBERTA

APRIL, 2018

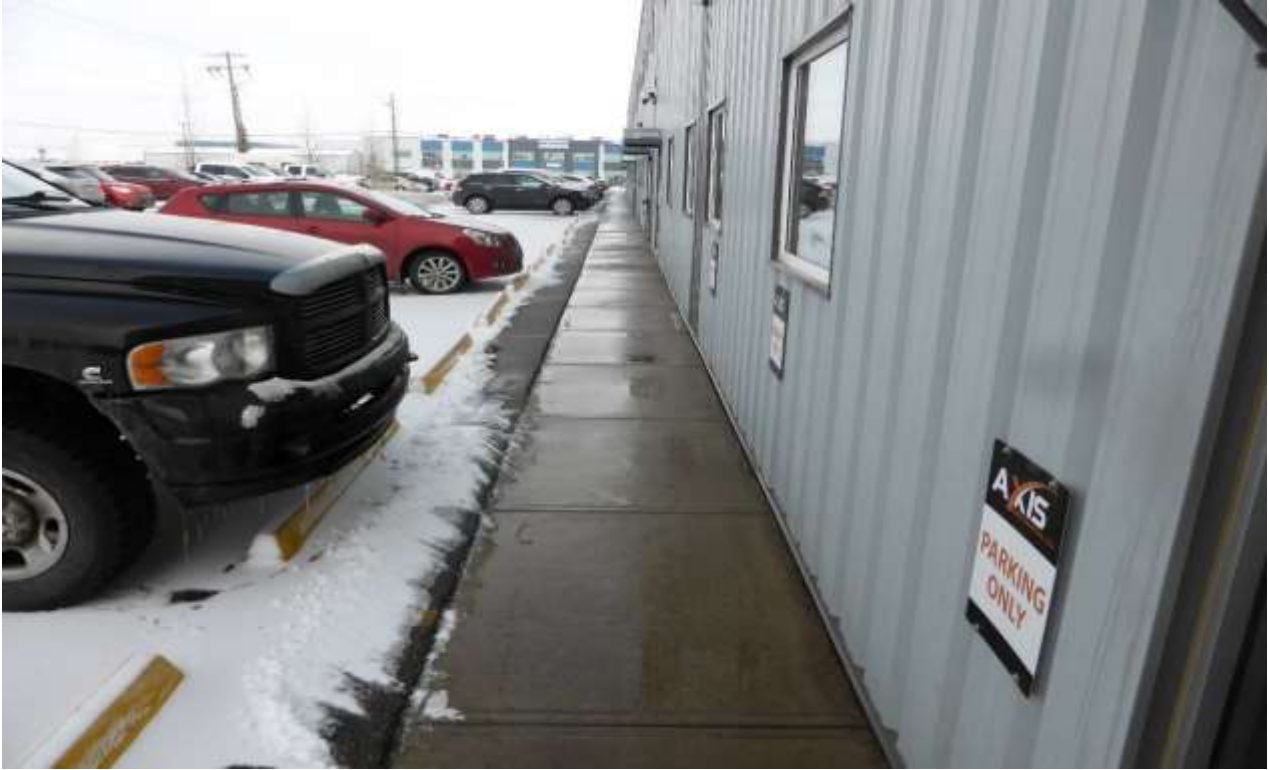
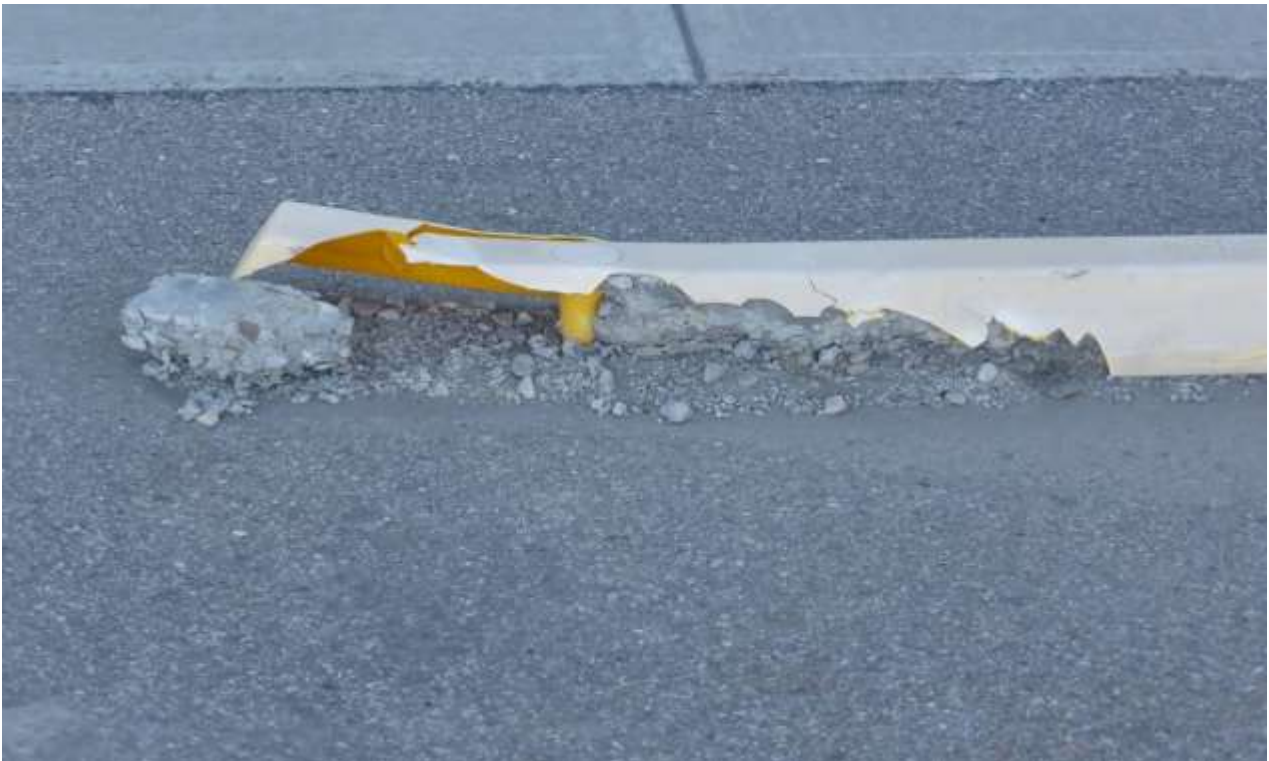
Reserve Component: (10) Site Improvements – Concrete Sidewalks & Curbs		
Physical Description	This component includes replacement of the front entrance concrete sidewalks as well as the curbs and spillways. It includes the parking barriers at the front and the vertical barriers at the back that were put in to protect the overhead doors. It is being assumed that 25% of the concrete will require replacement over the review period. See Figure 10-1 & 10-2.	
Financial Analysis	The have been no expenditures on this component in the last three years. There was an expenditure of \$5,579 in 2011/12 to install parking barriers at the front of the building.	
Potential Deterioration	Concrete will crack due to poor compaction of the ground it is poured on. It will deteriorate over time due to weathering from the elements. Products put on concrete to melt ice can also harm the surface of the concrete. Curbs can crack from poor installation or from mechanical contact with snow clearing equipment. Parking barriers can be dislodged or damaged with vehicle contact.

Condition Analysis	The concrete sidewalks, spillway and barriers were in good condition. There was some evidence of mechanical contact with the curbs at the entrance ways to the complex. Some of the parking barriers were damaged and will require replacement.	
Life Cycle Analysis	Date of Acquisition	2010/12
	Normal Life Span	25 Years
	Effective Age	12 Years
	Remaining Life Span	13 Years
Unit Quantity And Cost Estimates	Unit Quantity	600 sq. ft. (25%)
	Unit Cost Estimate	\$25 per sq. ft.
	Current Repair or Replacement Cost Estimate	\$15,000
	Estimated Year of Major Repair or Replacement	2022/32/42
Deficiency Analysis	See comments above. It is being assumed that parking barriers will be repaired as part of maintenance but funds have been included in 2022 for their replacement.

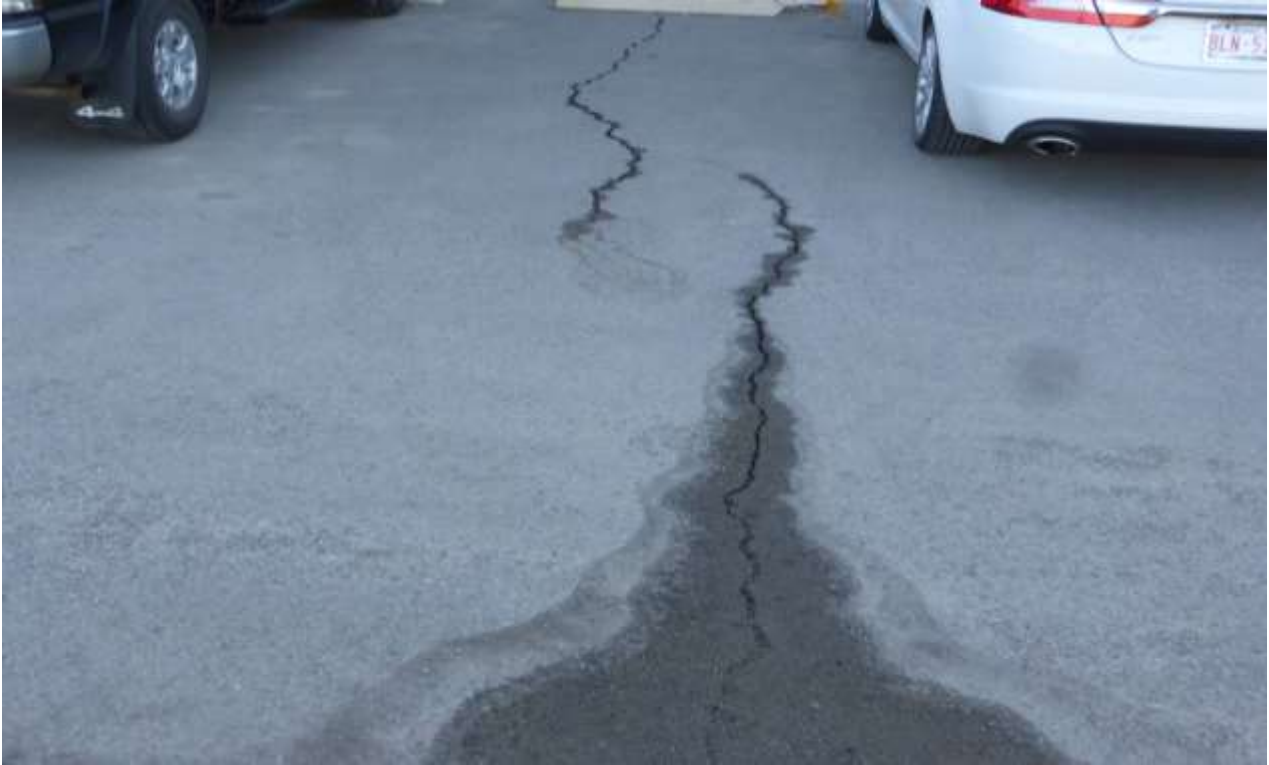
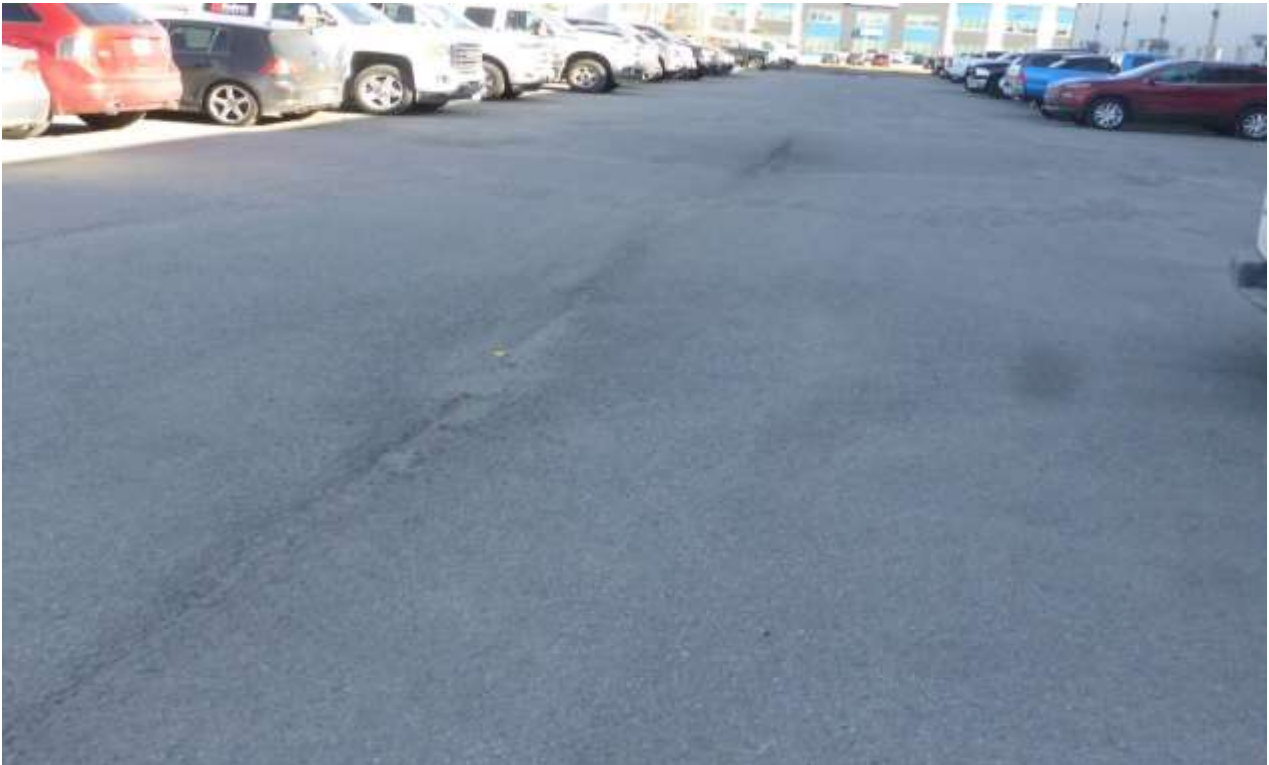
Reserve Component: (11) Site Improvements – Paving Repairs		
Physical Description	This component includes repairs and resurfacing the asphalt pavement at the front of the complex as well as the north gate entrance. It is being assumed that 25% of the pavement will be redone every 10 years. See Figure 11-1 & 11-2.	
Financial Analysis	There have been no expenditures on this component in the last three years. There is a proposed expenditure of \$30,000 in the current year to repair and resurface areas that have settled. Crack sealing will also be carried out.	
Potential Deterioration	If the ground settles the asphalt will settle and crack. Cracking allows moisture to get in and if not sealed it can lead to bigger cracks and major repair. Often utility installations are poorly compacted and settling can occur.	
Condition Analysis	There has been significant settling in several places which now hold water. There was a lot of cracking noted.

Life Cycle Analysis	Date of Acquisition	2010/2019
	Normal Life Span-25%	11 Years
	Effective Age	1 Years
	Remaining Life Span	10 Years
Unit Quantity And Cost Estimates	Unit Quantity	Allowance
	Unit Cost Estimate	\$30,000
	Current Repair or Replacement Cost Estimate	\$30,000
	Estimated Year of Major Repair or Replacement	2029/39
Deficiency Analysis	See comments above. Funds have been included every 10 years starting in 2029 for repairs and resurfacing similar to what is being proposed in the current year. Timing may vary.

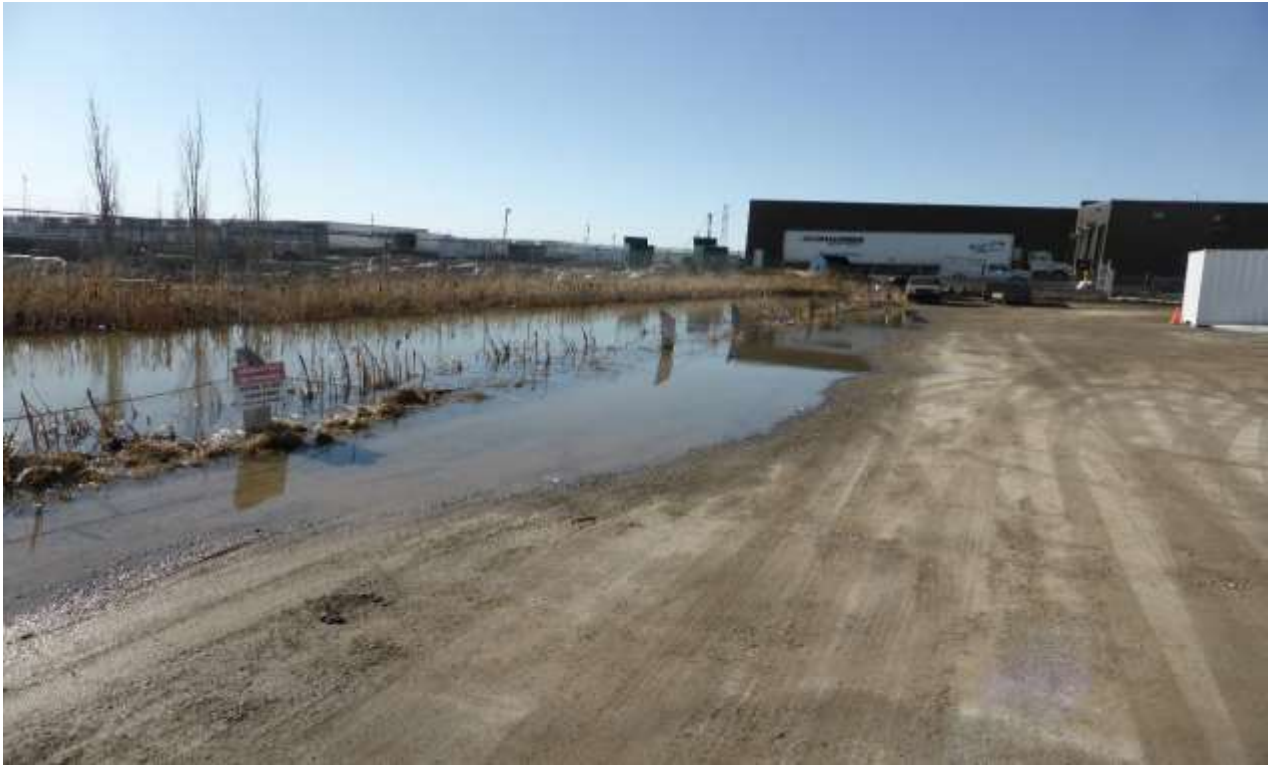
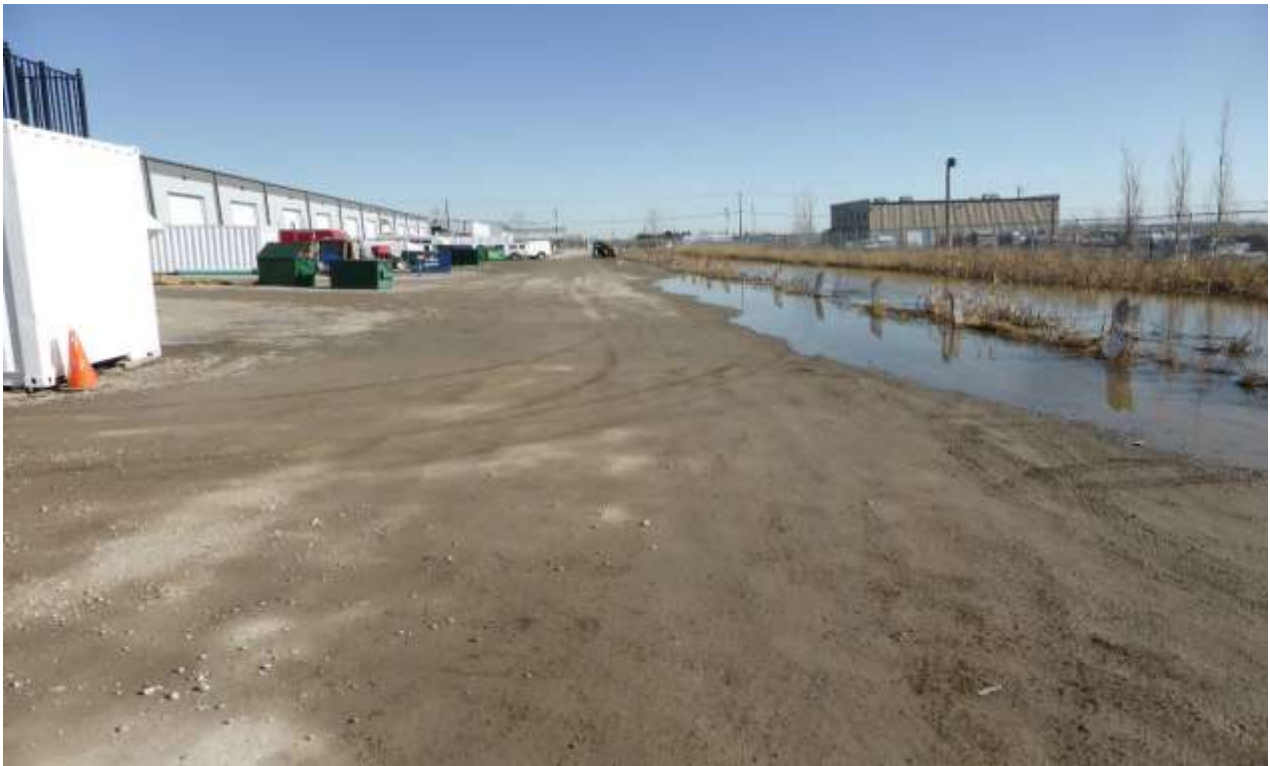
Reserve Component: (12) Site Improvements – Gravel Roadways		
Physical Description	This component includes repairs and re-gravelling of the gravel roadways that run along the south and east side of the complex. See Figure 12-1 & 12-2.	
Financial Analysis	There have been no expenditures on this component in the last 3 years.	
Potential Deterioration	If the ground settles it may require grading to relevel and some new gravel to maintain a proper base.	
Condition Analysis	The roadways appeared to be in need of grading and gravel in the near future.	
Life Cycle Analysis	Date of Acquisition	2010
	Normal Life Span	15 Years
	Effective Age	9 Years
	Remaining Life Span	6 Years
Unit Quantity And Cost Estimates	Unit Quantity	Allowance
	Unit Cost Estimate	\$5,000
	Current Repair or Replacement Cost Estimate	\$5,000
	Estimated Year of Major Repair or Replacement	2020/25/30
Deficiency Analysis	See comments above. Funds have been included every 5 years starting in 2020. Actual timing could vary.

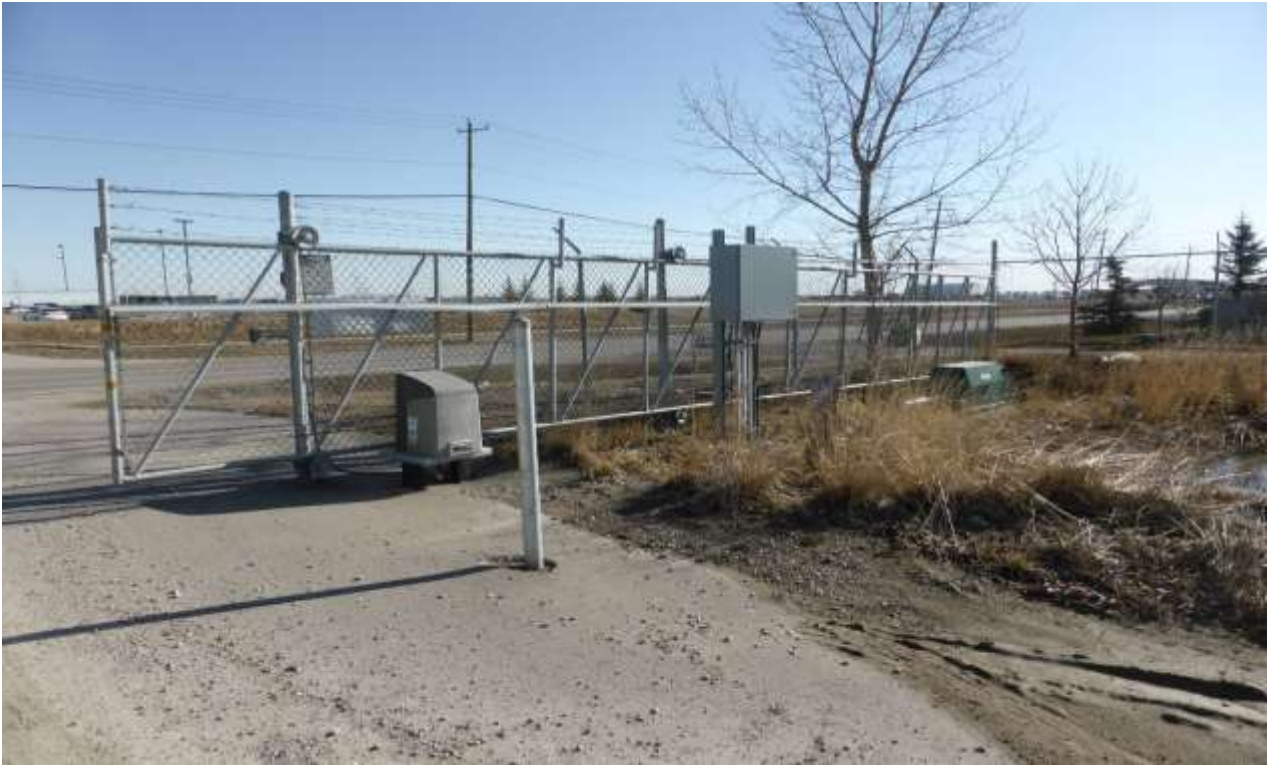
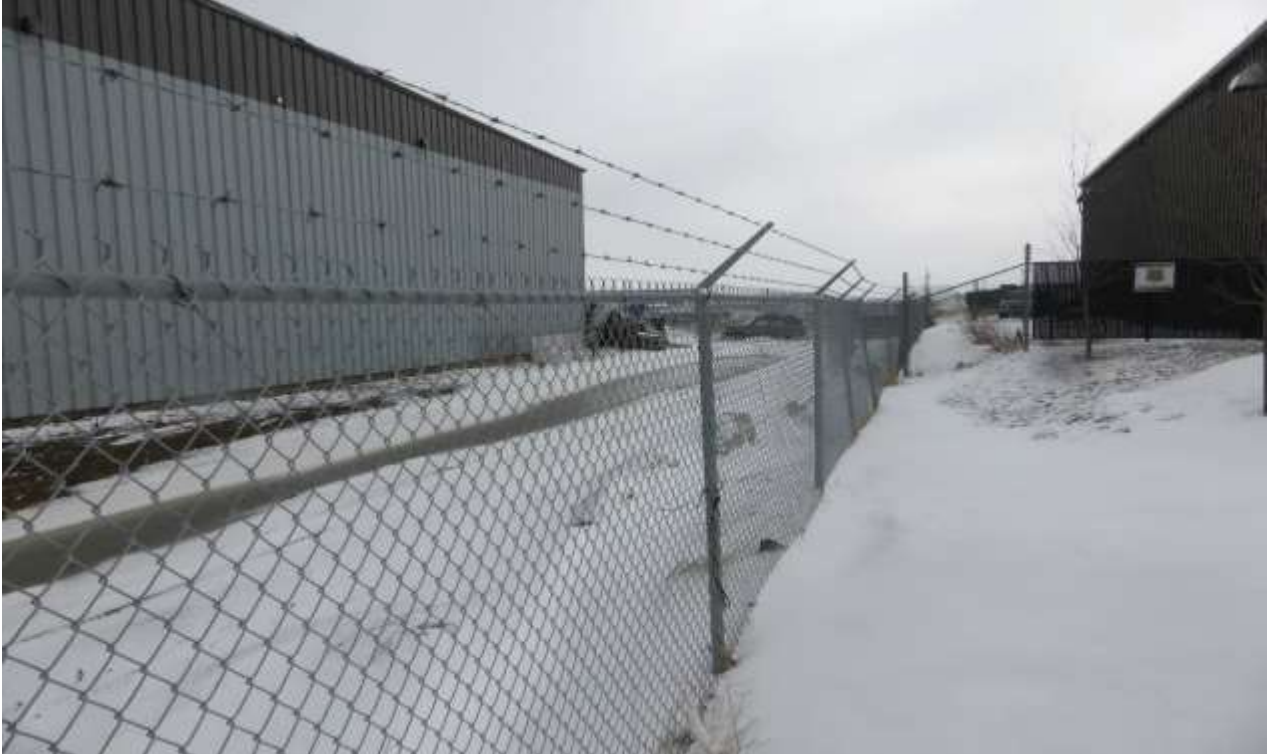
Reserve Component: (13) Site Improvements – Fencing		
Physical Description	This component includes the replacement of the chain link fencing around the complex as well as the automated north entrance gate and secondary south manual gates. It includes the automated gate opener on the north gate. It is being assumed that 25% of the fencing and gates require replacement over the review period. See Figure 13-1 & 13-2.	
Financial Analysis	There have been no expenditures on this component in the last three years. There was an expenditure of \$1,650 in 2011/12 to install secondary swing gates.	
Potential Deterioration	Chain link fencing can be damaged by mechanical contact. The fencing can come loose from the posts and rails and the posts can become loose if not properly secured to the concrete base. Automated opening mechanisms will need ongoing repair and replacement.	
Condition Analysis	The chain link fencing appeared in good condition. There was some evidence of mechanical contact along the south side of the property. The automated north gate system was functioning satisfactorily when there. It was reported that there were some issues with gate clearance in the winter months that was going to be resolved as part of maintenance this year.

Life Cycle Analysis	Date of Acquisition	2010
	Normal Life Span	30 Years
	Effective Age	9 Years
	Remaining Life Span	21 Years
Unit Quantity And Cost Estimates	Unit Quantity	250 l. ft. (25%)
	Unit Cost Estimate	\$60 per l. ft.
	Current Repair or Replacement Cost Estimate	\$15,000
	Estimated Year of Major Repair or Replacement	2024/34/40
Deficiency Analysis	No deficiencies were identified with this component. Funds have been included every 10 years starting in 2024 for minor repairs as may be required.

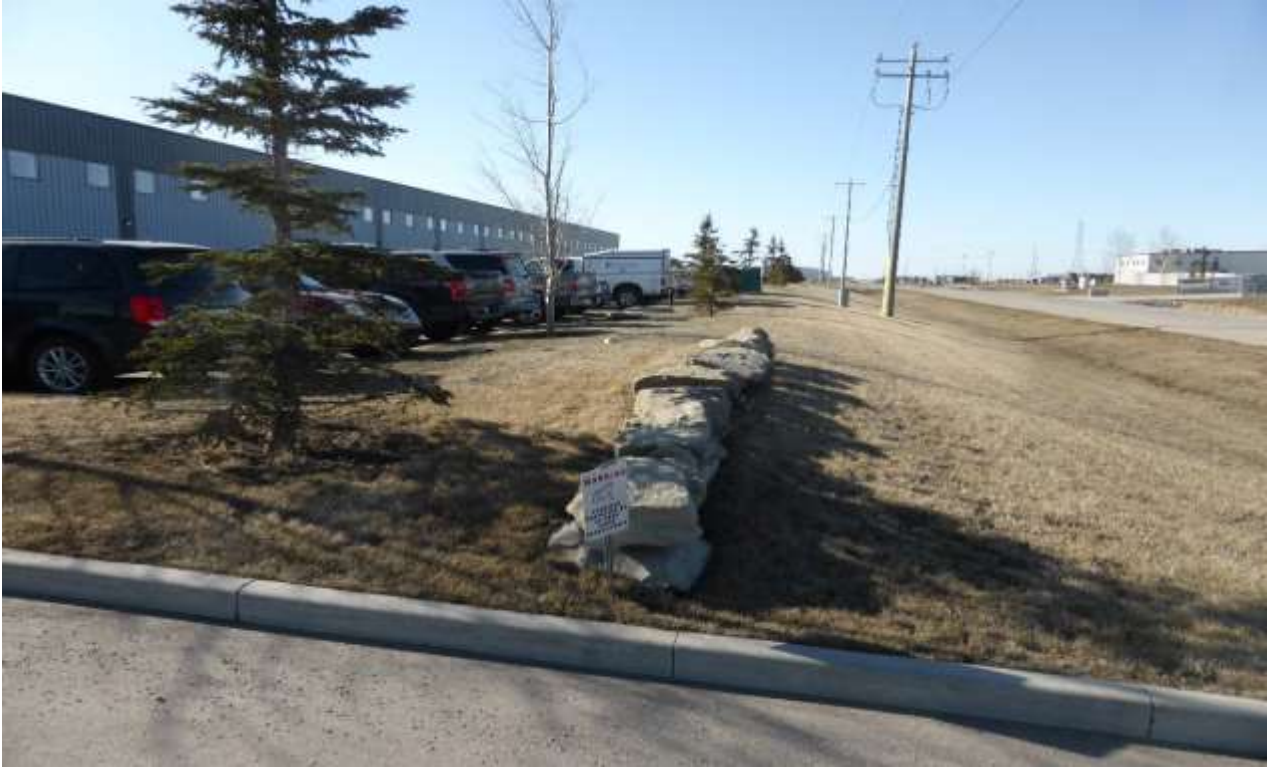
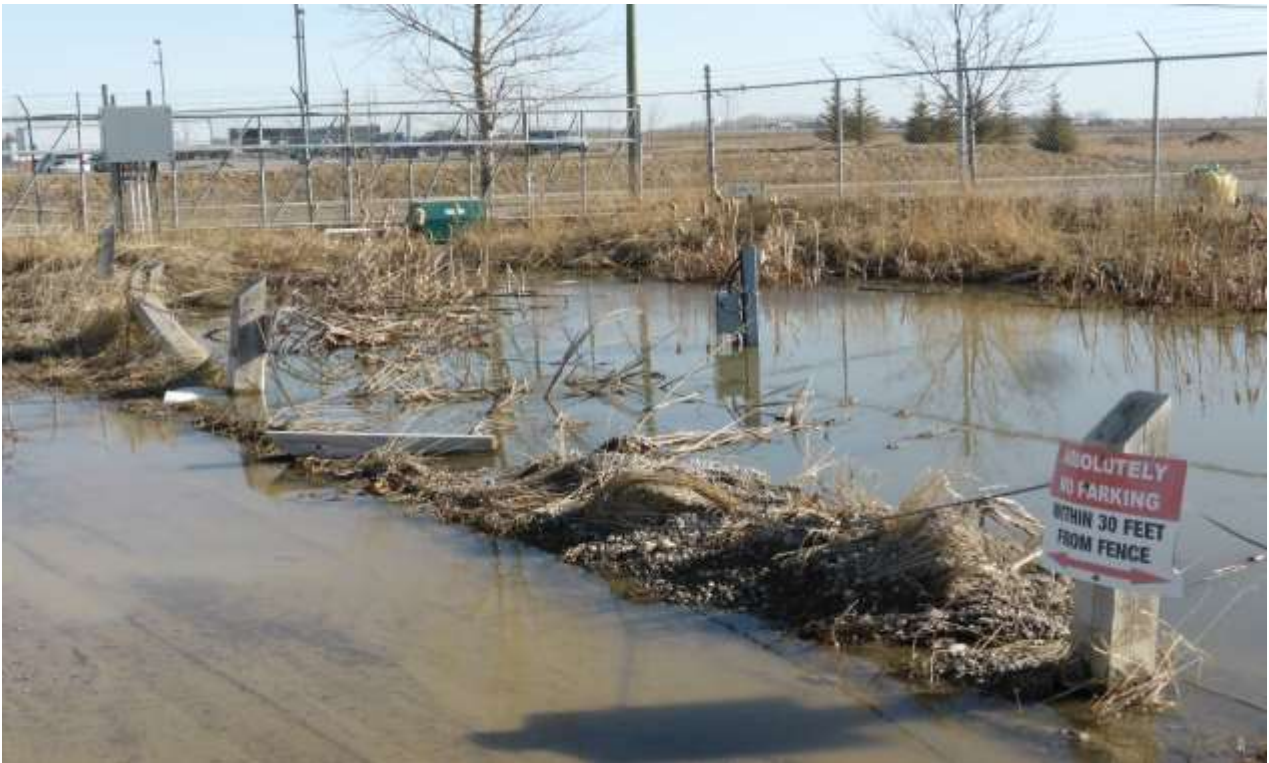
Reserve Component: (14) Site Improvements – Landscaping & Irrigation		
Physical Description	This component includes non-annual costs to maintain the landscaping and the irrigation system. It includes any retaining wall repairs as well as repairs to the cable barrier at the back of the complex. See Figure 14-1 & 14-2.	
Financial Analysis	There have been no expenditures on this component in the last 3 years. There has been some work done to install a drainage system along the south side entrance to the property. The irrigation pump has been relocated since the last study.	
Potential Deterioration	Trees may require pruning as they mature. Sprinkler systems may need repair to heads and controllers may need replacement. The irrigation pump may require replacing. Retaining walls and barriers may require repairs due to mechanical contact. Drainage areas may require reworking and irrigation pumps may need repair or replacement.

Condition Analysis	The landscaping appeared in average condition. The trees at the front appeared to be struggling and may be lacking water. Some dead and diseased trees were noticed. The parking barrier at the back has been damaged in several areas by mechanical contact.	
Life Cycle Analysis	Date of Acquisition	2010
	Normal Life Span	15 Years
	Effective Age	5 Years
	Remaining Life Span	10 Years
Unit Quantity And Cost Estimates	Unit Quantity	Allowance
	Unit Cost Estimate	\$15,000
	Current Repair or Replacement Cost Estimate	\$15,000
	Estimated Year of Major Repair or Replacement	2020/23/26/29
Deficiency Analysis	See comments above. This is a contingency for any of the above related work. Timing is an estimate. Funds have been included every 3 years starting in 2020.
