RESERVE FUND STUDY

FRONTIER BUSINESS PARK
CONDOMINIUM CORPORATION #1010603
240040 FRONTIER PLACE S.E.
ROCKY VIEW, ALBERTA

MAY, 2012

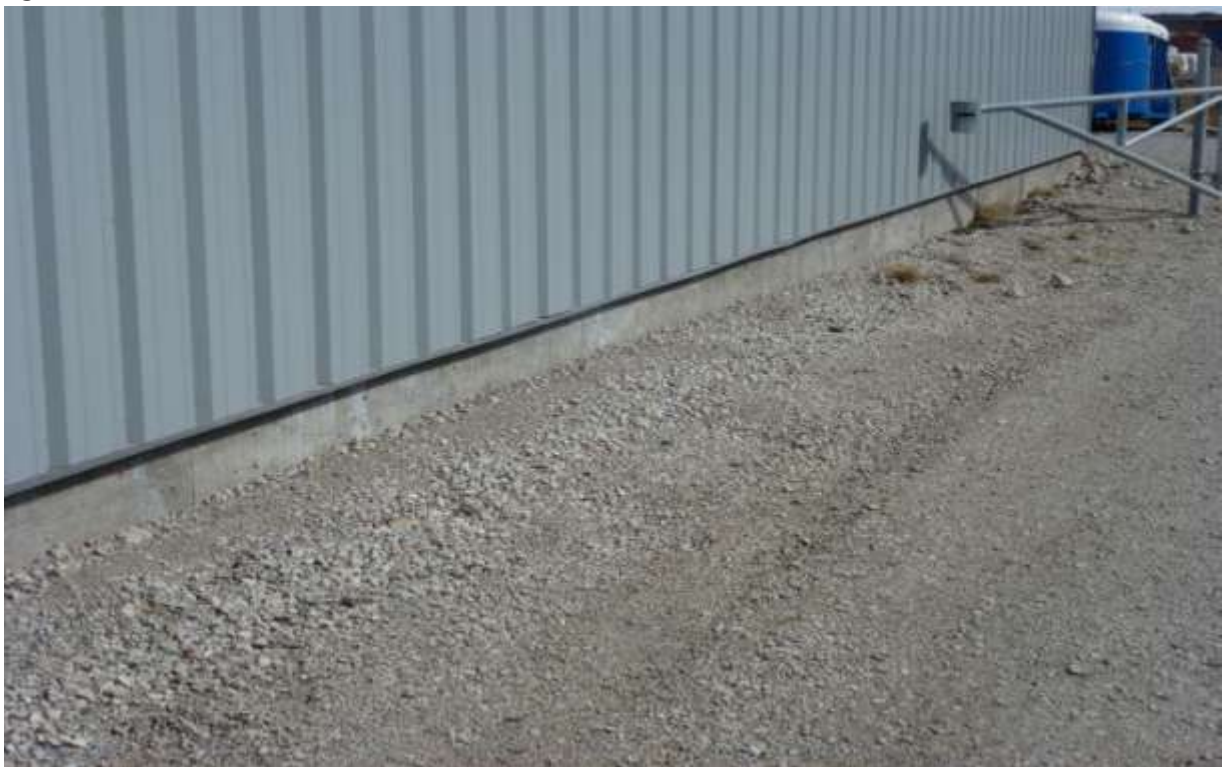
Figure 1-2

Reserve Component: (1) Building – Foundations		
Physical Description	This component includes all foundations. This is a contingency to allow for funds for an Engineering report should there be any foundation issues in future years. See figure 1-1&1-2	
Financial Analysis	This component has had no recorded expenditures to date.	
Potential Deterioration	Potential deterioration includes cracking due to settling or from moisture infiltration. Water proofing if not properly installed will separate from the concrete and allow moisture to get through to the concrete leading to further deterioration.	
Condition Analysis	There were no observed issues with the building foundations.	
Life Cycle Analysis	Date of Acquisition:	2010
	Normal Life Span	25 years
	Effective Age	3 years
	Remaining Life Span	22 years
Unit Quantity And Cost Estimates	Unit Quantity	Allowance
	Unit Cost Estimate	\$ 10,000
	Current Repair or Replacement Cost Estimate	\$ 10,000

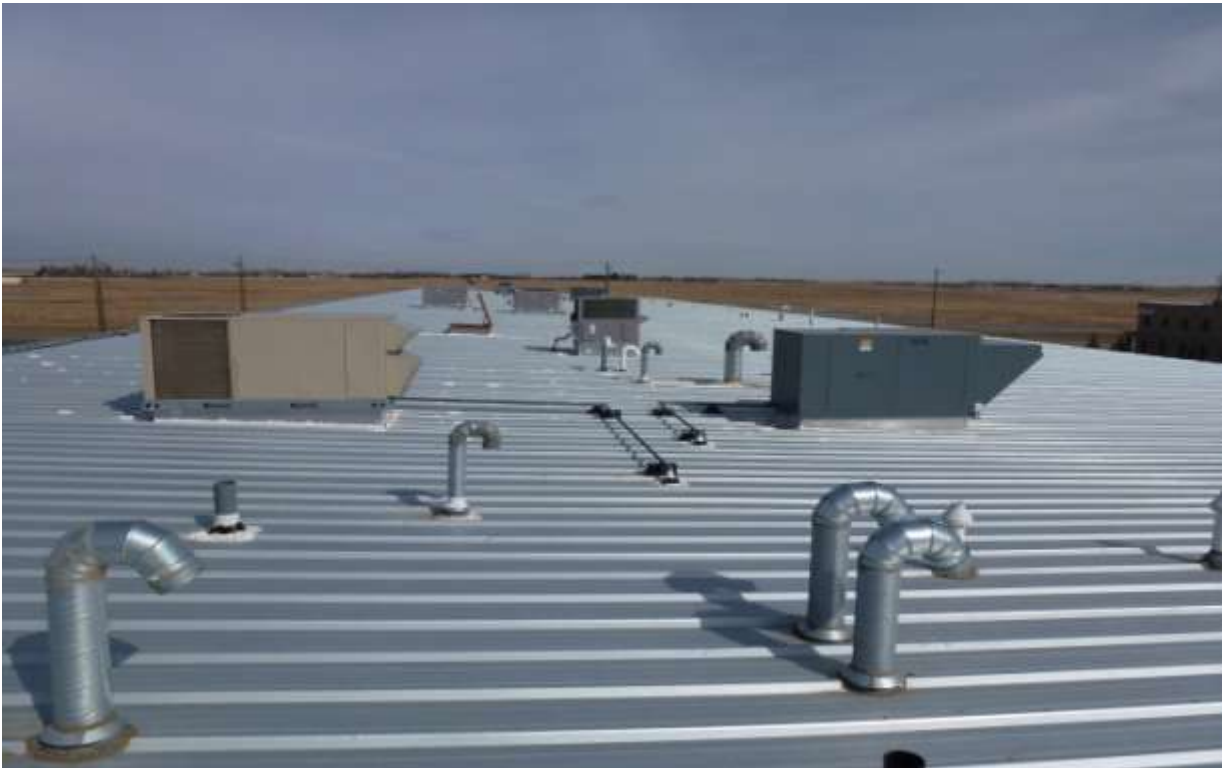
Figure 2-2

Reserve Component: (2) Building – Metal Walls and Roof- Repairs		
Physical Description	This component includes the metal building walls and roof as well as the one common metal door accessing the utility room. It also includes the canopies which were installed over the front entrance doors. This component has a replacement life exceeding the 25 years required by this reserve fund study. This study is reserving for minor repairs only. See figure 2-1&2-2	
Financial Analysis	There has been \$9360 spent on this component in 2011/12 to install Canopies over front entrance doors.	
Potential Deterioration	Metal surfaces can be dented by mechanical contact. Screws used to secure the metal may require replacement over time. The metal roof may require repairs associated with holes or protrusions for equipment or from heavier items being dropped on it. The metal utility room door may require hardware repairs.

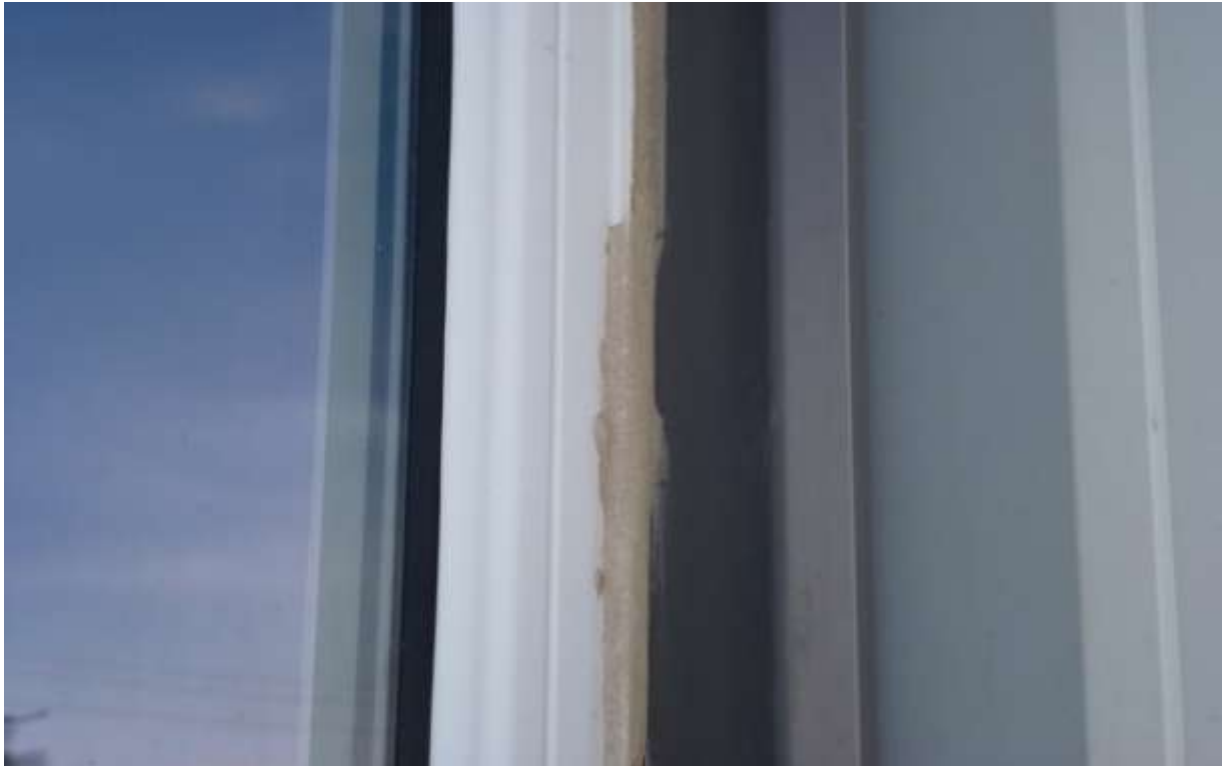
Figure 3-1

Reserve Component: (3) Building- Caulking		
Physical Description	This component includes caulking around all windows, doors, protrusions and joints between dissimilar materials. See Fig. 3-1-3-2	
Financial Analysis	There have been no expenditures to date on this component.	
Potential Deterioration	Caulking breaks down over time and becomes hard leading to cracking and shrinkage. If the seal is broken moisture infiltration can occur causing significant damage to the inner wall areas of the building.	
Condition Analysis	The caulking in appeared to be in good condition where it could be accessed and inspected.	
Life Cycle Analysis	Date of Acquisition:	2010
	Normal Life Span	15 years
	Effective Age	3 years
	Remaining Life Span	12 years
Unit Quantity And Cost Estimates	Unit Quantity	Allowance
	Unit Cost Estimate	\$10,000
	Current Repair or Replacement Cost Estimate	\$10,000
	Estimated Year of Major Repair or Replacement	2025

Deficiency Analysis	No deficiencies were identified with this component.

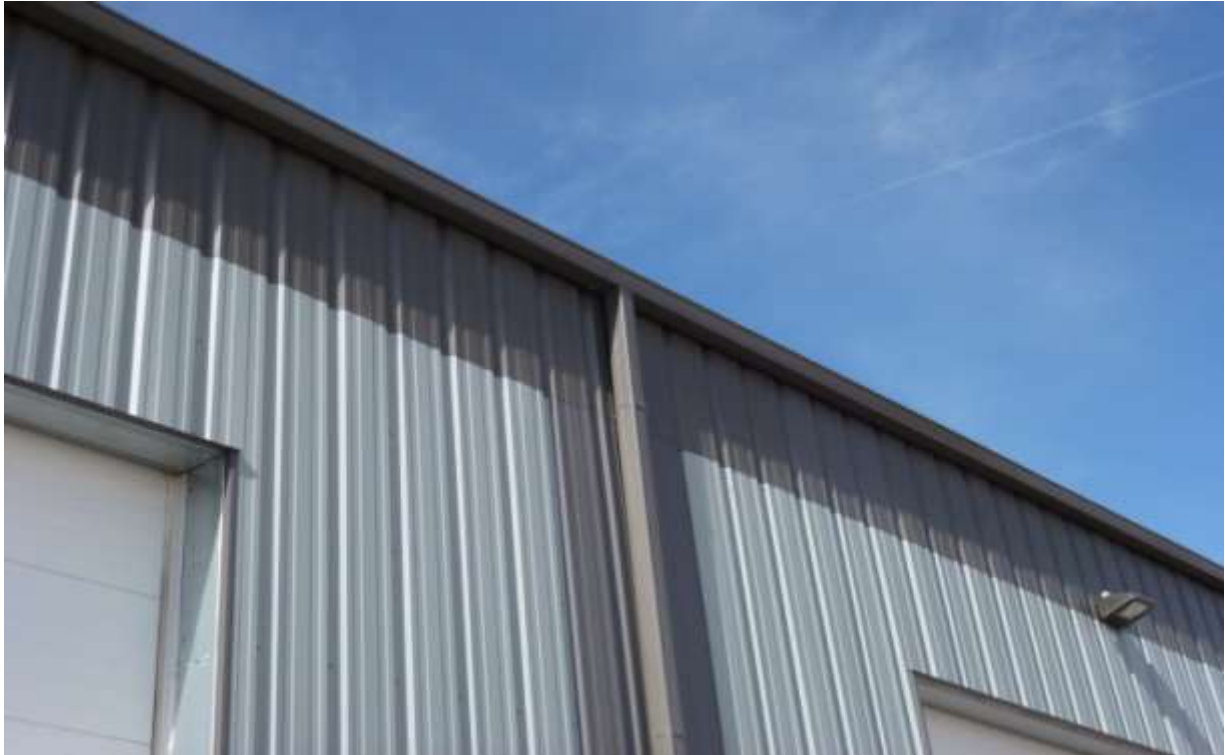
Figure 4-1

Reserve Component: (4) Building- Metal Eaves trough &Downspouts									
Physical Description	This component covers the metal eaves troughs and downspouts on the building. See Figure 10-1 and 10-2.								
Financial Analysis	There have been no expenditures on this component to date.								
Potential Deterioration	Metal eaves troughs can come loose from the area they are secured to. They can be bent or broken by contact with equipment used for landscaping. They can fade in color over time. They can develop leaks.								
Condition Analysis	The eaves trough and downspouts appeared to be in good condition.								
Life Cycle Analysis	<table border="0"> <tr> <td>Date of Acquisition:</td> <td>2010</td> </tr> <tr> <td>Normal Life Span</td> <td>25 years</td> </tr> <tr> <td>Effective Age</td> <td>3 years</td> </tr> <tr> <td>Remaining Life Span</td> <td>22 years</td> </tr> </table>	Date of Acquisition:	2010	Normal Life Span	25 years	Effective Age	3 years	Remaining Life Span	22 years

Date of Acquisition:	2010								
Normal Life Span	25 years								
Effective Age	3 years								
Remaining Life Span	22 years								
Unit Quantity And Cost Estimates	<table border="0"> <tr> <td>Unit Quantity</td> <td>Allowance</td> </tr> <tr> <td>Unit Cost Estimate</td> <td>\$ 5000.</td> </tr> <tr> <td>Current Repair or Replacement Cost Estimate</td> <td>\$ 5000</td> </tr> <tr> <td>Estimated Year of Major Repair or Replacement</td> <td>2035</td> </tr> </table>	Unit Quantity	Allowance	Unit Cost Estimate	\$ 5000.	Current Repair or Replacement Cost Estimate	\$ 5000	Estimated Year of Major Repair or Replacement	2035
Unit Quantity	Allowance								
Unit Cost Estimate	\$ 5000.								
Current Repair or Replacement Cost Estimate	\$ 5000								
Estimated Year of Major Repair or Replacement	2035								
Deficiency Analysis	No deficiencies were identified with this component.

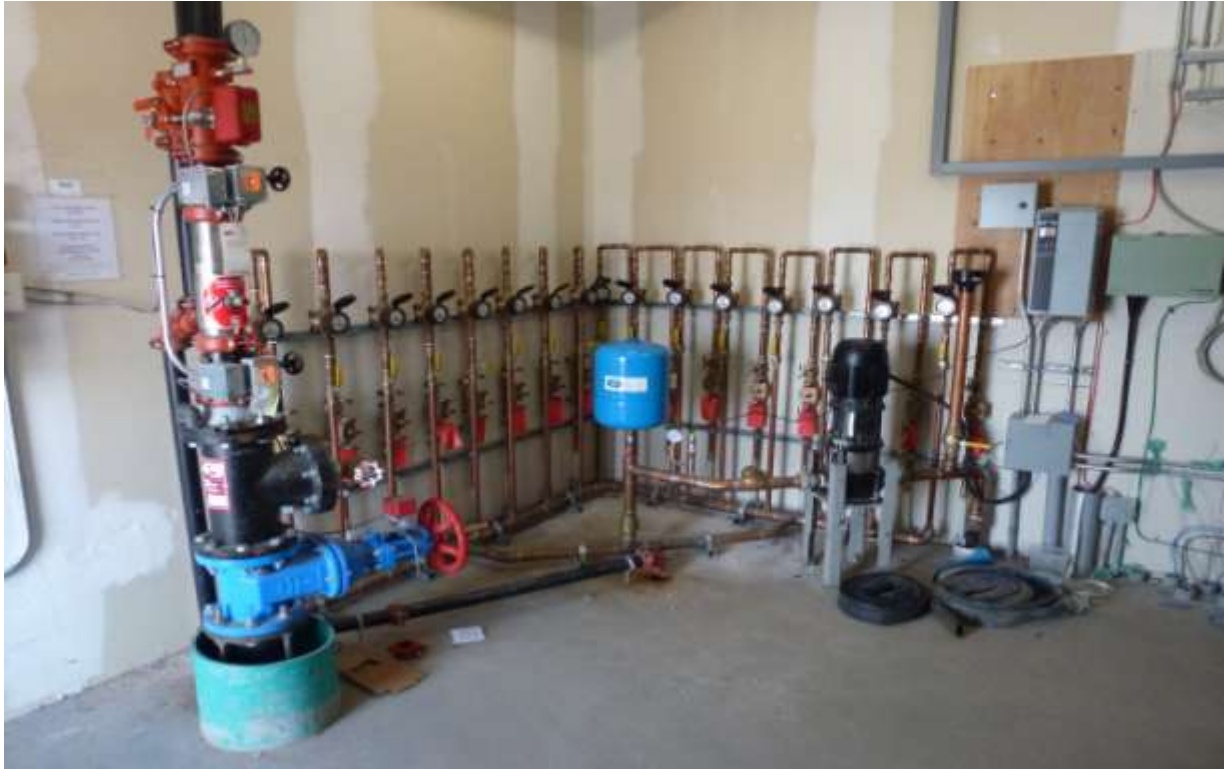
Figure 5-1

Reserve Component: (5) Mechanical and Electrical – Water & Sewer System									
Physical Description	This component includes the self contained water and sewer system for this condominium complex. The underground water and sewer tanks, charge pump, surge tank and all piping to and from the tanks are part of this component. Everything that will become redundant when connected to city services is included. See Figure 5-1&5-2								
Financial Analysis	There has been no expenditures on this component to date								
Potential Deterioration	Underground storage tanks can develop leaks. Underground piping can fail. Charge pumps may require repair or replacement.								
Condition Analysis	The water and sewer system including the transfer pumps and related equipment appeared in good condition.								
Life Cycle Analysis	<table> <tr> <td>Date of Acquisition:</td> <td>2010</td> </tr> <tr> <td>Normal Life Span</td> <td>15 years</td> </tr> <tr> <td>Effective Age</td> <td>3 years</td> </tr> <tr> <td>Remaining Life Span</td> <td>12 years</td> </tr> </table>	Date of Acquisition:	2010	Normal Life Span	15 years	Effective Age	3 years	Remaining Life Span	12 years

Date of Acquisition:	2010								
Normal Life Span	15 years								
Effective Age	3 years								
Remaining Life Span	12 years								
Unit Quantity And Cost Estimates	<table> <tr> <td>Unit Quantity</td> <td>Allowance</td> </tr> <tr> <td>Unit Cost Estimate</td> <td>\$15,000</td> </tr> <tr> <td>Current Repair or Replacement Cost Estimate</td> <td>\$15,000</td> </tr> <tr> <td>Estimated Year of Major Repair or Replacement</td> <td>2025</td> </tr> </table>	Unit Quantity	Allowance	Unit Cost Estimate	\$15,000	Current Repair or Replacement Cost Estimate	\$15,000	Estimated Year of Major Repair or Replacement	2025
Unit Quantity	Allowance								
Unit Cost Estimate	\$15,000								
Current Repair or Replacement Cost Estimate	\$15,000								
Estimated Year of Major Repair or Replacement	2025								
Deficiency Analysis	No deficiencies were identified on this component.

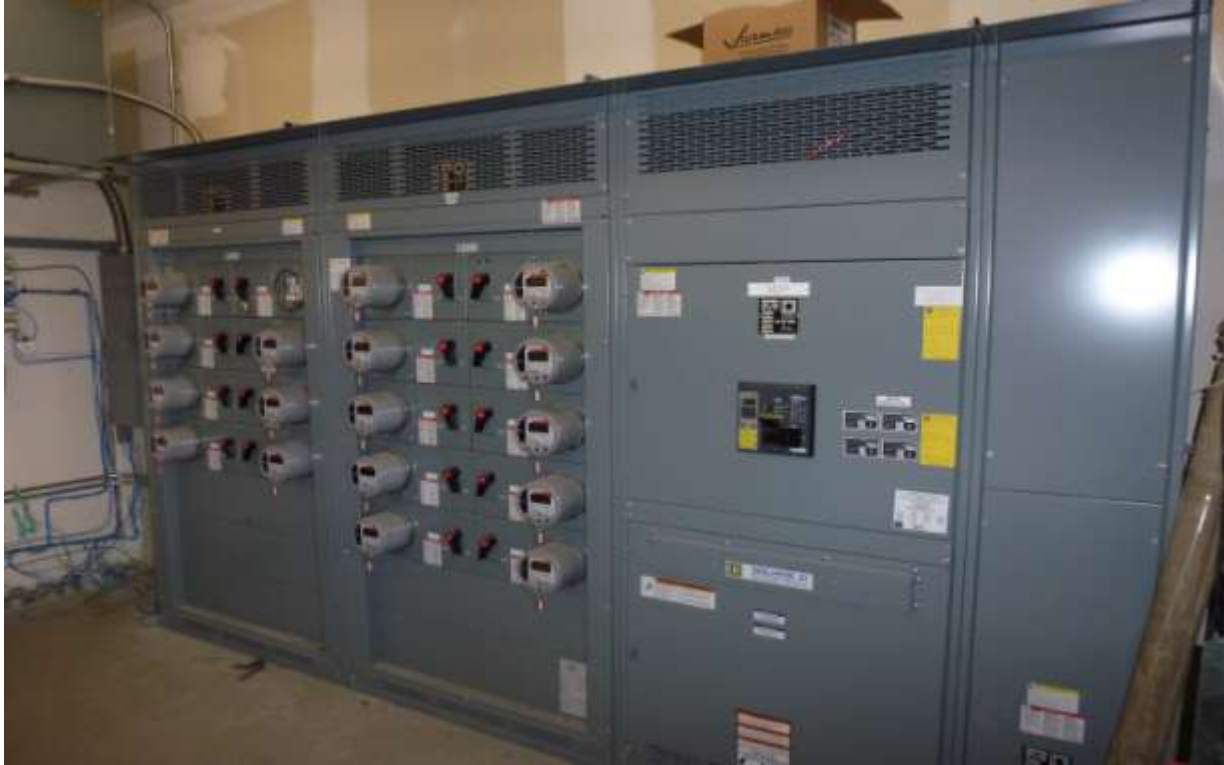
Figure 6-1

Reserve Component: (6) Mechanical and Electrical – Electrical & Lighting		
Physical Description	This component includes all the electrical switch gear, panels, transformers and wiring. It also includes the telephone, cable and all lighting inside the utility room. It includes the electric space heater in the utility room as well as all outside lighting. This is an allowance to allow for any major repairs or replacements that may arise over time. See Figure 6-1&6-2	
Financial Analysis	There have been no recorded expenditures on this component to date.	
Potential Deterioration	Electrical panels, wiring, transformers and switch gear should be maintenance free however this allowance provides for a contingency in case there is an issue in the future. Lighting fixtures are often replaced for visual reasons. Electrical space heaters can wear out.	
Condition Analysis	There were no issues with any of the systems when viewed.

Life Cycle Analysis	Date of Acquisition:	2010
	Normal Life Span	15 years
	Effective Age	3 years
	Remaining Life Span	12years
Unit Quantity And Cost Estimates	Unit Quantity	Allowance
	Unit Cost Estimate	\$10,000
	Current Repair or Replacement Cost Estimate	\$10,000.
	Estimated Year of Major Repair or Replacement	2025
Deficiency Analysis	There were no deficiencies viewed with this component.

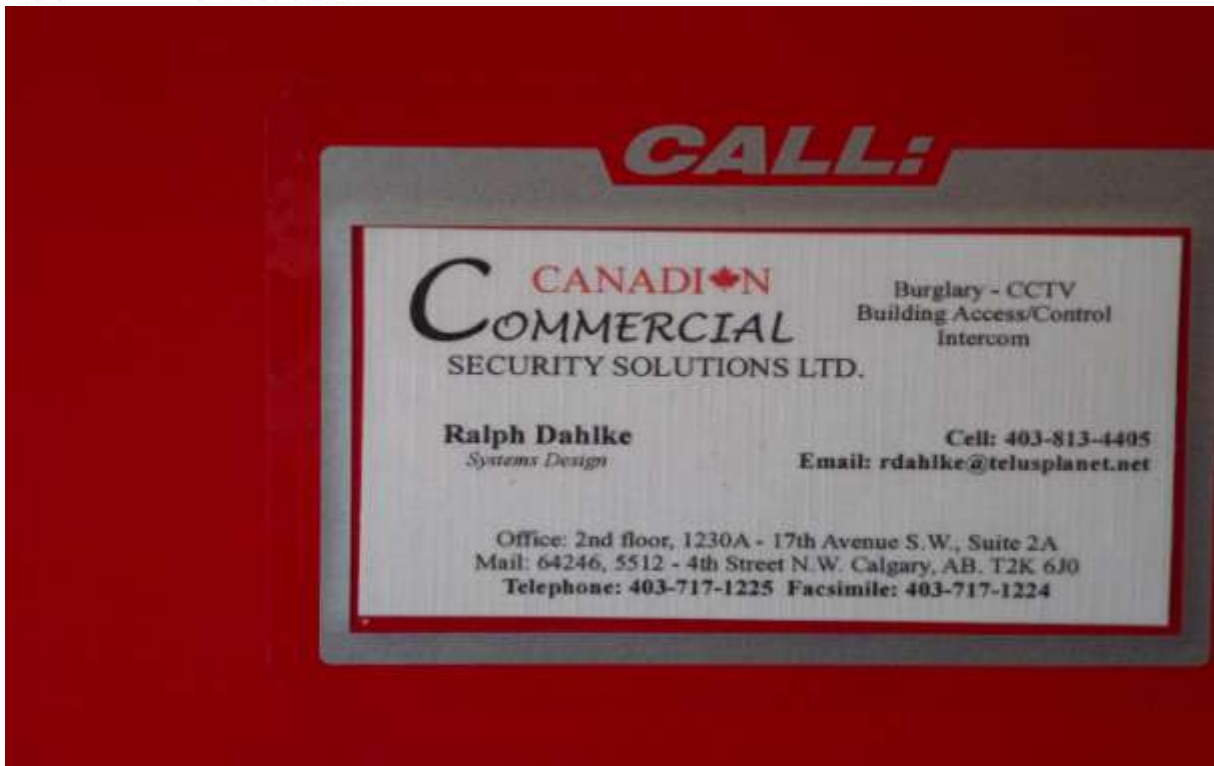
Reserve Component: (7) Mechanical and Electrical – Call out System		
Physical Description	This component includes the automated call out system that is triggered by the fire alarm panel. It also includes the local alarm that is used for the water and sewer system. See Figure 7-1	
Financial Analysis	There have been no expenditures on this component to date.	
Potential Deterioration	Call out systems become obsolete due to technology changes which make repair uneconomic.	
Condition Analysis	The systems appear to be functioning okay with no reports of any issues.	
Life Cycle Analysis	Date of Acquisition:	2010
	Normal Life Span	20 years
	Effective Age	3 years
	Remaining Life Span	17years
Unit Quantity And Cost Estimates	Unit Quantity	Allowance
	Unit Cost Estimate	\$5000
	Current Repair or Replacement Cost Estimate	\$5000
	Estimated Year of Major Repair or Replacement	2030
Deficiency Analysis	There were no deficiencies identified with this component.

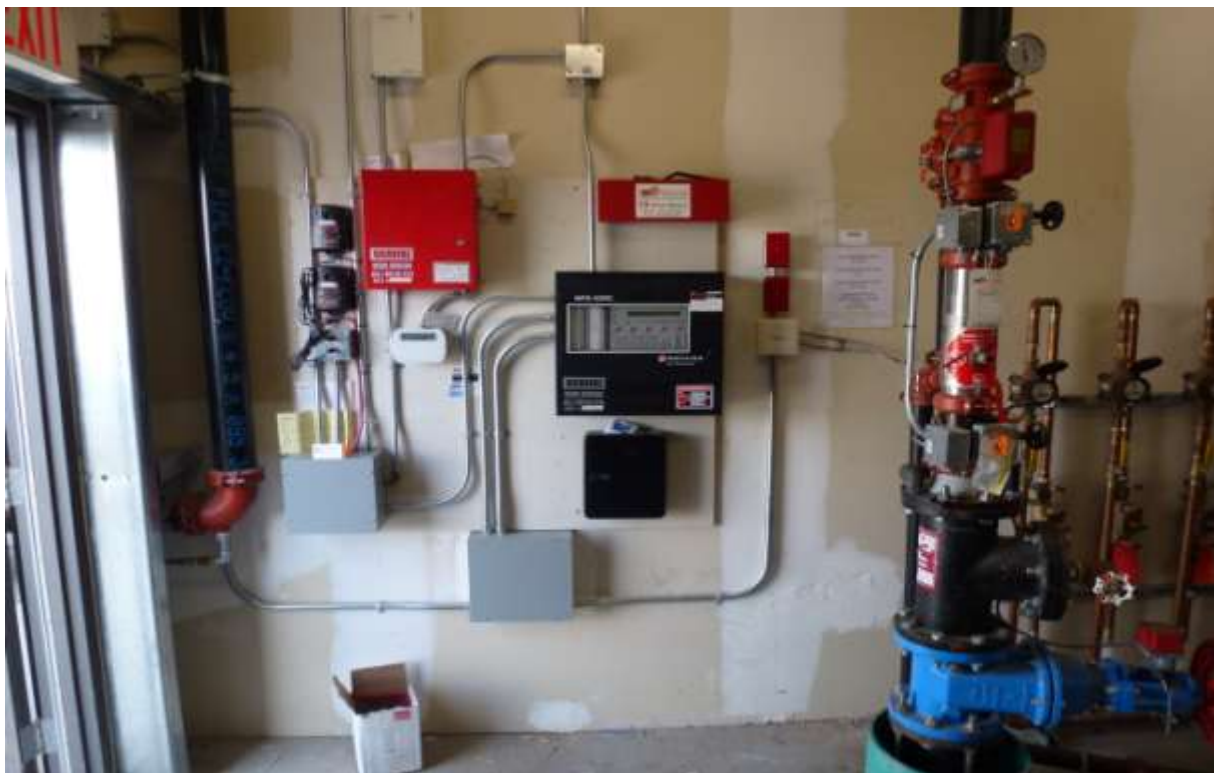
Reserve Component: (8) Mechanical & Electrical – Fire Alarm System		
Physical Description	This component includes the fire alarm panel and all related interconnections from the equipment. See Figure 7-2	
Financial Analysis	There have been expenditures on this component to date.	
Potential Deterioration	Fire regulations change over time making it necessary to keep all equipment up to code. Equipment becomes obsolete or simply non functional when tested.	
Condition Analysis	The fire alarm system is a Honey Well NFS-320C. The system appeared to be functioning okay. The system has been checked within the last year.	
Life Cycle Analysis	Date of Acquisition:	2010
	Normal Life Span	20 years
	Effective Age	3 years
	Remaining Life Span	17 years
Unit Quantity And Cost Estimates	Unit Quantity	Allowance
	Unit Cost Estimate	\$ 5000
	Current Repair or Replacement Cost Estimate	\$ 5000
	Estimated Year of Major Repair or Replacement	2030

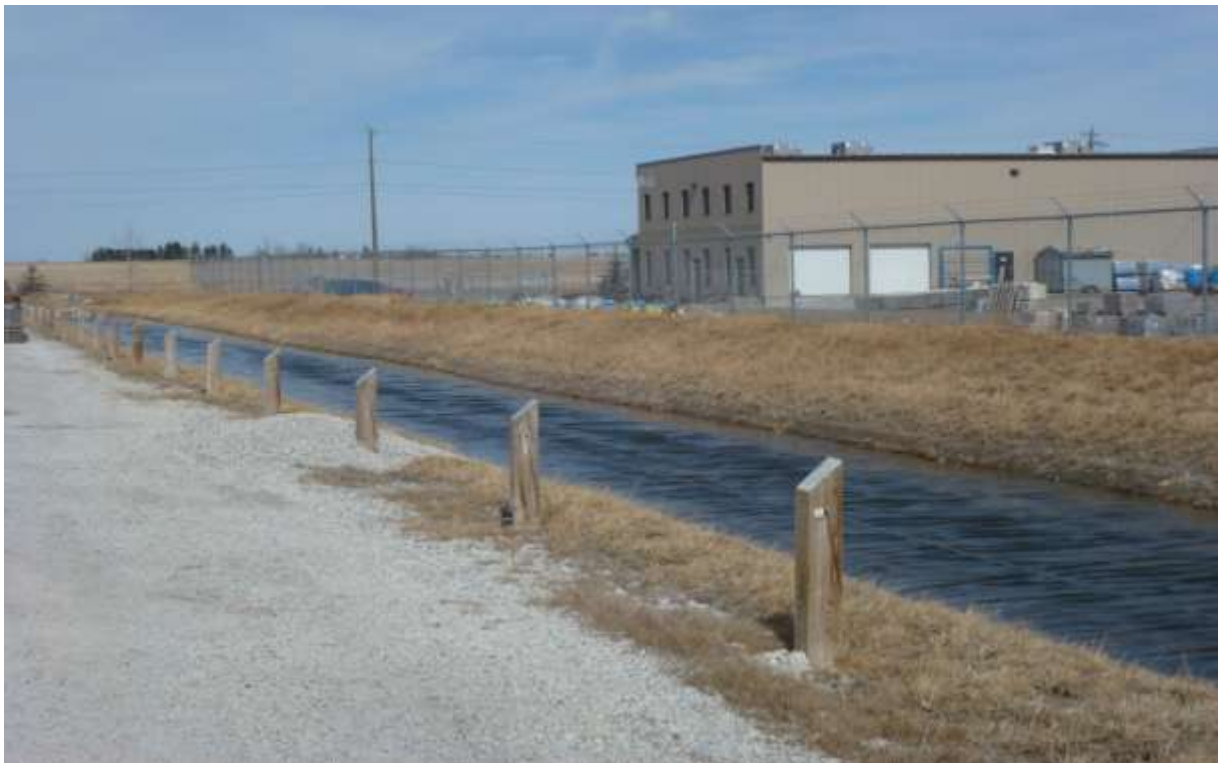
Figure 9-2

Reserve Component: (9) Site Improvements – Fence &Gates									
Physical Description	This component includes the chain link fence around the back of the complex as well as two 25 foot entrance gates and two secondary swing gates. It is being assumed that 50% of the fence and gates will be replaced over a 25 year period. See Figure 9-1& 9-2.								
Financial Analysis	There has been an expenditure of \$1650 on installing secondary swing gates in 2011/2012.								
Potential Deterioration	Chain link fence can come loose from the posts it is secured to. The posts can lose support due to mechanical contact or from poor installation. Gates can have hinges break off or can be damaged by vehicle traffic. Strand barb wire can come loose due to fence movement.								
Condition Analysis	The fences and gates look in good condition. Some of the barb wire was loose and the south section of the fence appeared to have had some mechanical contact and was not all straight.

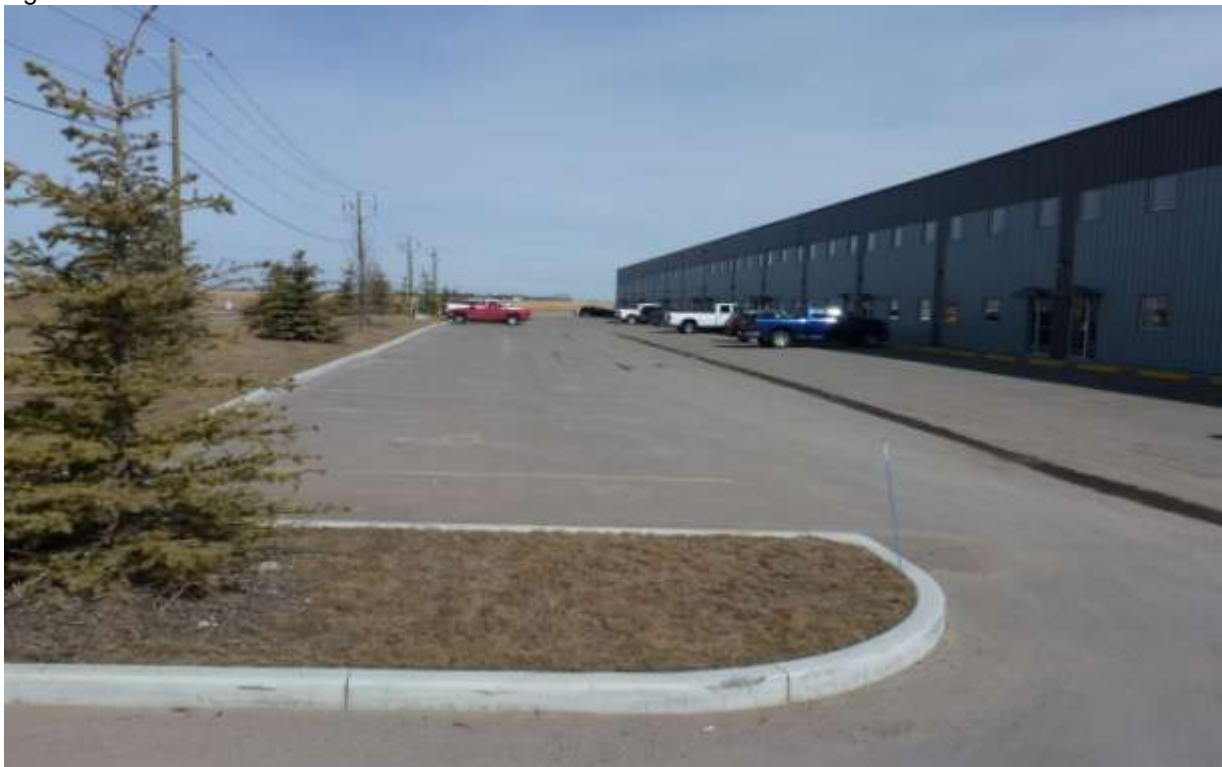
Figure 10-2

Reserve Component: (10) Site Improvements – Sidewalks& Curbs									
Physical Description	This component includes the exterior sidewalk along the front of the building, concrete curbs at the front of the building where it is paved and also the concrete drainage spillway along the north side of the building. It also includes the parking barriers recently installed in front of the complex. It also includes the vertical barriers at the back of the units that protect the doors. It is being assumed that 20% of these components will require replacement over a 25 year period. See Figure 10-1 &10-2								
Financial Analysis	There was an expenditure of \$5579 in 2011/12 to install the parking barriers at the front of the building.								
Potential Deterioration	Concrete will crack due to poor compaction of ground it is poured on. It will deteriorate over time due to weathering from the elements. Products put on to prevent ice buildup can harm the surface of the concrete. Curbs can crack if not properly installed. They are often broken or damaged by mechanical contact with equipment. Parking barriers can become dislodge or damaged with vehicle contact.

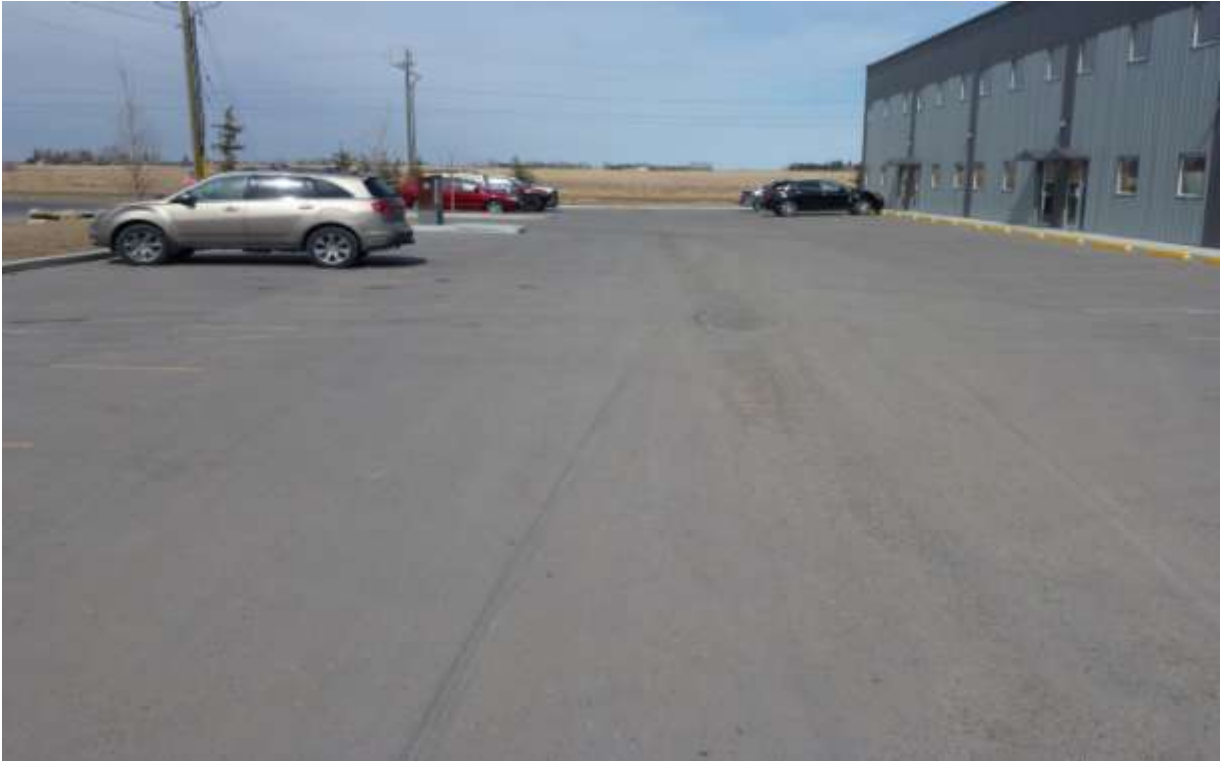
Figure 11-1

Reserve Component: (11) Site Improvements – Asphalt Parking Areas		
Physical Description	This component includes the asphalt pavement at the front of the complex as well as at the north gate entrance. See Figure 11-1& 11-2	
Financial Analysis	There have been no recorded expenditures on this component to date.	
Potential Deterioration	If the ground settles asphalt will settle and crack. Cracking allows moisture to get in and if not sealed it can lead to bigger cracks and major repair.	
Condition Analysis	The asphalt paving appears to be in good condition. Some settling was identified where services run into the building most likely due to poor compaction. In discussion with the condominium board it sounded as though the south entrance area may be paved in the near future at which time the settling of the asphalt would be taken care of. Since timing was not clear it was agreed that if this was done it would be considered a special assessment as the reserve fund would be largely depleted if the work was carried out in the near future.

Life Cycle Analysis	Date of Acquisition:	2010
	Normal Life Span	25 years
	Effective Age	3 years
	Remaining Life Span	22 years
Unit Quantity And Cost Estimates	Unit Quantity	36,000 sq. ft.
	Unit Cost Estimate	\$1.60 per sq. ft.
	Current Repair or Replacement Cost Estimate	\$57,600
	Estimated Year of Major Repair or Replacement	2035
Deficiency Analysis	Monitor settling and cracks and consider sealing cracks when they occur to extend the life of the asphalt. See comments above regarding additional paving which should be handled by a special assessment if it were to proceed. Funds have been included every 6 years for minor repairs or resealing cracks. Consider some fill around the utility pipe that sticks up in the parking lot and is a potential safety hazard.(See Figure- 11-2)

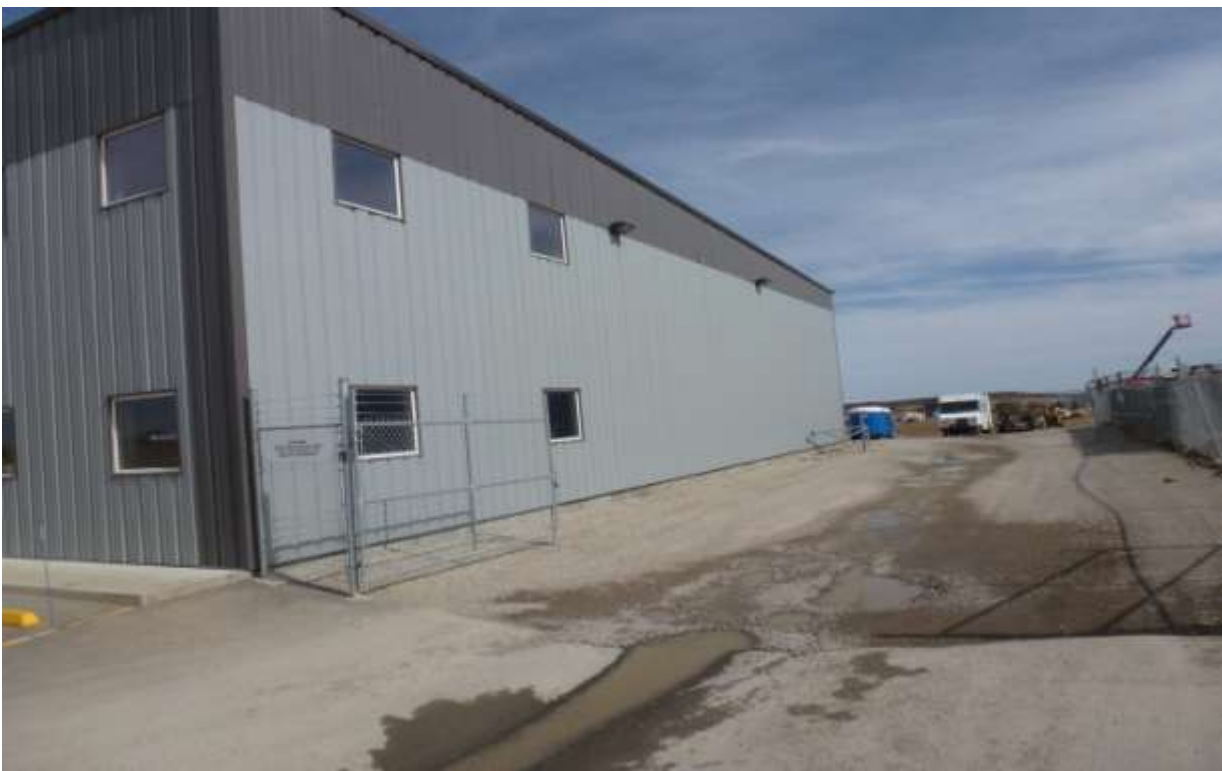
Figure 12-2

Reserve Component: (12) Site Improvements – Gravel Parking Areas		
Physical Description	This component includes the gravel parking area along the south side and at the back of the complex. See Figure 12-1& 12-2	
Financial Analysis	There have been no expenditures on this component to date.	
Potential Deterioration	If the ground settles it may be necessary to grade and re-level the parking area and some new gravel may be required.	
Condition Analysis	The gravel parking area appeared in good condition. Some settling was identified but nothing major.	
Life Cycle Analysis	Date of Acquisition:	2010
	Normal Life Span	10 years
	Effective Age	1 years
	Remaining Life Span	9 years
Unit Quantity And Cost Estimates	Unit Quantity	48,000 sq. ft.
	Unit Cost Estimate	\$0.1 per sq. ft.
	Current Repair or Replacement Cost Estimate	\$4,800
	Estimated Year of Major Repair or Replacement	\$1000 every second year
Deficiency Analysis	Monitor settling and re-grade and fill with gravel as required.

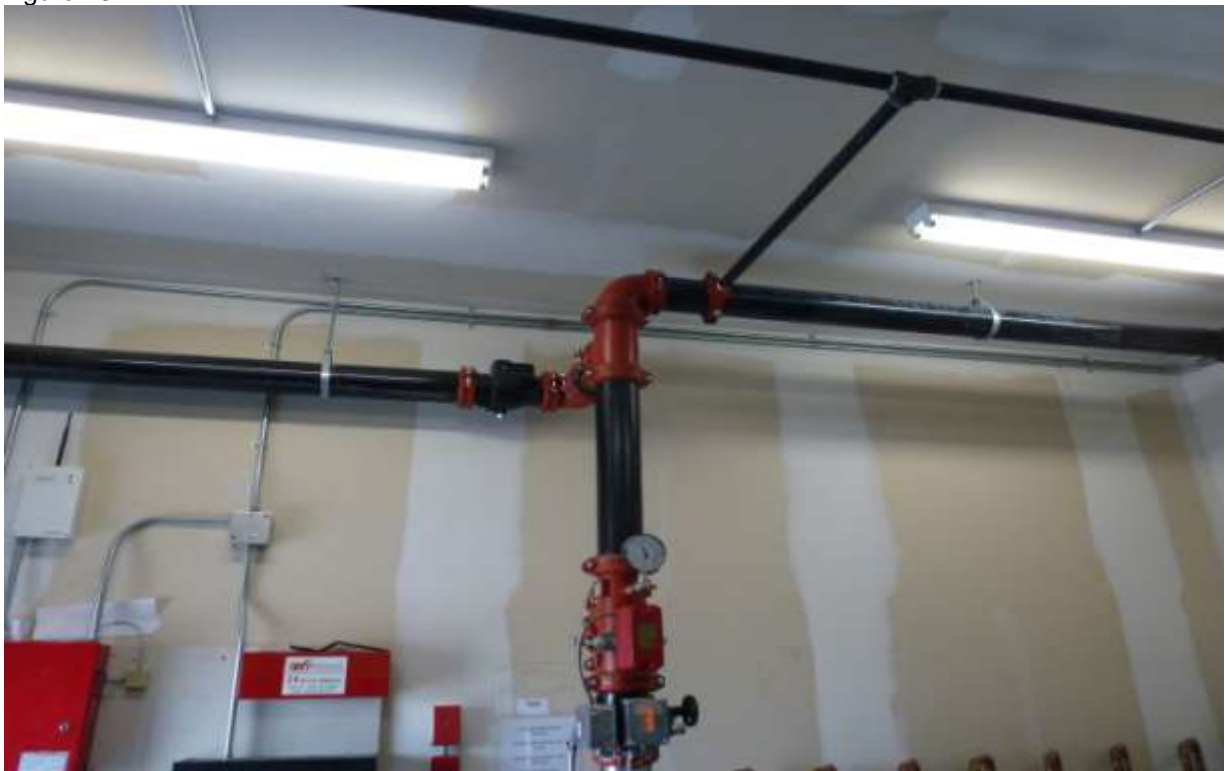
Figure 13-2

Reserve Component: (13) Site Improvements – Site Services		
Physical Description	This component is a contingency for costs associated with the water, sewer, natural gas lines and all related piping on site. It includes all piping, valves and meters from the building water and sewer inlet through to each unit in the complex. It also includes all of the firewater system, standpipes and the sprinkler system. See Figure 13-1& 13-2	
Financial Analysis	There have been no expenditures on this component to date.	
Potential Deterioration	Water and sewer is localized at this facility and is covered by a separate component through to the main distribution and collection points. This component handles the distribution of water and sewer throughout the complex. Natural gas is provided individually to each unit and is the individual owner’s responsibility. The firewater system is common property. Piping for these items from the mechanical room throughout the building and back is considered a Condominium responsibility. Valves may leak and require replacement. Firewater valves may require replacement. Settling may cause lines to break and require servicing. Most of this equipment should last the life of the complex and this is simply a contingency for a failure anywhere if it ever were to occur.

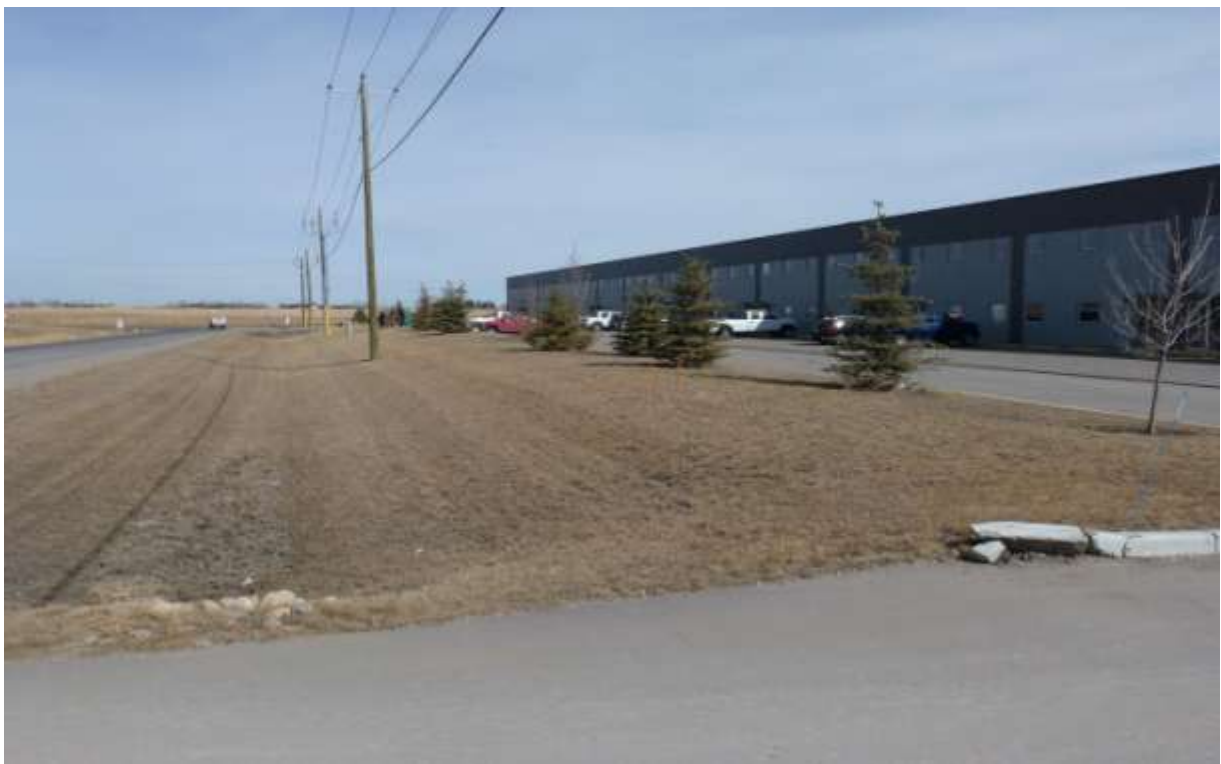
Figure 14-2

Reserve Component: (14) Site Improvements – Landscaping& Irrigation		
Physical Description	This component includes all exterior landscaping and irrigation It includes any retaining walls as well as the cable retaining barrier at the back of the complex next to the irrigation canal. See Figure 14-1& 14-2	
Financial Analysis	There have been no expenditures on this component to date	
Potential Deterioration	Trees may require pruning or replacement. The irrigation pump may require replacement. Irrigation piping may require replacing. Retaining walls and barriers may require repair due to mechanical contact or from settling issues.	
Condition Analysis	Landscaping was in good condition. It looked like there may be a few trees that may require replacing. There was mention that the irrigation pump may be relocated but after discussion with the board it was not included in this report as it would most likely be a maintenance issue.
